Safety Recall **Code: 66K8**

Rear Wheel Arch Trim

October 22, 2019

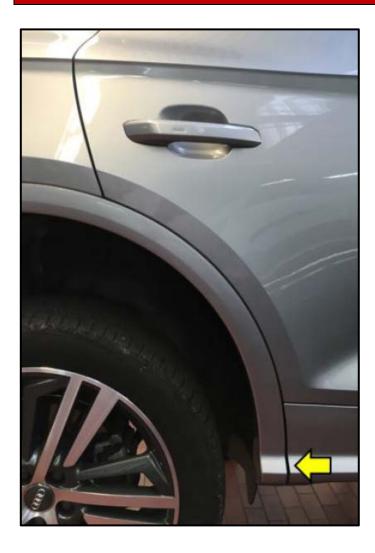
Replace clips for lower wheel arch trim "cap" <arrow> on both left rear and right rear wheel arch trim.
