PRODUCT CAMPAIGN BULLETIN

APPLICABILITY: 2017-19MY Impreza
2018-19MY Crosstrek

NUMBER: WUQ-02R

SUBJECT: Ignition Coil Short Circuit

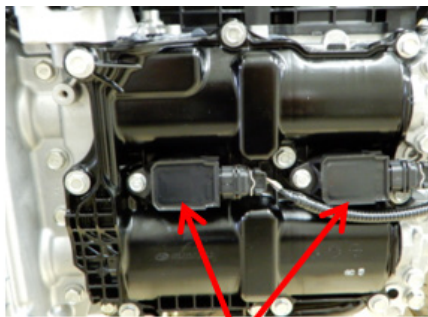
Ignition Coil Check Points

Step 3: Inspect all 4 ignition coils CLOSELY for any damage, cracking, fissures, etc. Were any cracks, fissures or other damage found on any of the 4 ignition coils? Coil removal is not necessary as any damage will be external.

OK

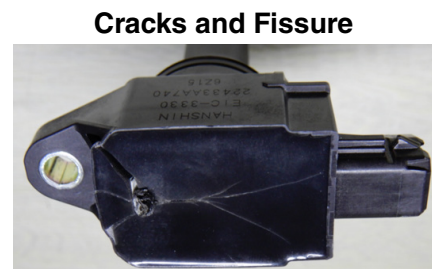
Cracking

Fissure

NG

Cracks and Fissure

YES: Proceed to **Step 4** and using the SSM, check for any stored DTCs (rare case).

Step 4: When performing the DTC check, are any DTCs, P0301, 2, 3 or 4: Cylinder Misfire Detected or P0420: for Catalyst Efficiency Below Threshold Bank 1 stored in memory?

NO: None of the listed DTCs are stored. Replace ONLY any damaged ignition coils and Fuse 21 (if blown) in the M/B. When complete, proceed to **Step 5** and reprogram the ECM following the normal FlashWrite procedure.

YES: One or more of the listed DTCs are current or in history. Replace any damaged ignition coils, Fuse 21 (if blown) in the M/B and the EPF assembly following the procedure in the applicable Service Manual. When completed, proceed to **Step 5** and reprogram the ECM following the normal FlashWrite procedure.
