PRODUCT CAMPAIGN BULLETIN

APPLICABILITY: 2017-19MY Impreza
2018-19MY Crosstrek

NUMBER: WUQ-02

SUBJECT: Ignition Coil Short Circuit

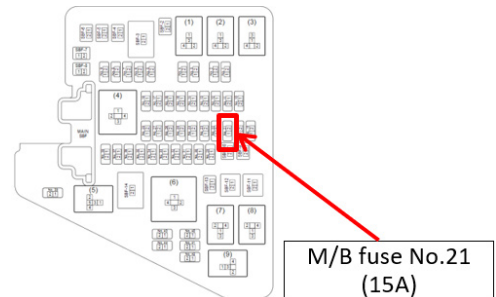
Step 2: Remove the lid from the under-hood Main Fuse Box (M/B) and inspect Fuse 21. Is Fuse 21 blown?

NO: Diagnose the hard / no start according to the applicable Service Manual. Proceed to **Step 3**.

YES: Proceed to **Step 3** and inspect all 4 of the ignition coils closely.

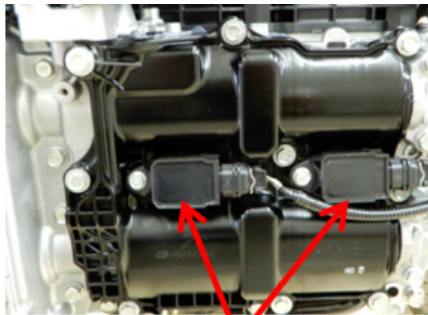
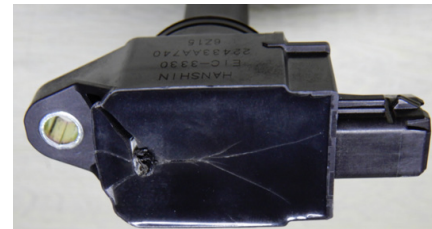
Ignition Coil Check Points

Step 3: Inspect all 4 ignition coils CLOSELY for any damage, cracking, fissures, etc. Were any cracks, fissures or other damage found on any of the 4 ignition coils? Coil removal is not necessary as any damage will be external.

Cracking

Fissure

NG

Cracks and Fissure

YES: Proceed to **Step 4** and using the SSM, check for any stored DTCs (rare case).

NO: None of the listed DTCs are stored. Replace ONLY any damaged ignition coils and Fuse 21 (if blown) in the M/B. When complete, proceed to **Step 5** and reprogram the ECM following the normal FlashWrite procedure.

YES: One or more of the listed DTCs are current or in history. Replace any damaged ignition coils, Fuse 21 (if blown) in the M/B and the EPF assembly following the procedure in the applicable Service Manual. When completed, proceed to **Step 5** and reprogram the ECM following the normal FlashWrite procedure.
