SAFETY RECALL

VOLVO Trucks North America
Greensboro, NC USA

| Date | Number | Page |
|---|---|---|
| 11/19 | RVXX1906 | 1 (4) |

Steering Gearbox Fastener Re-Torque

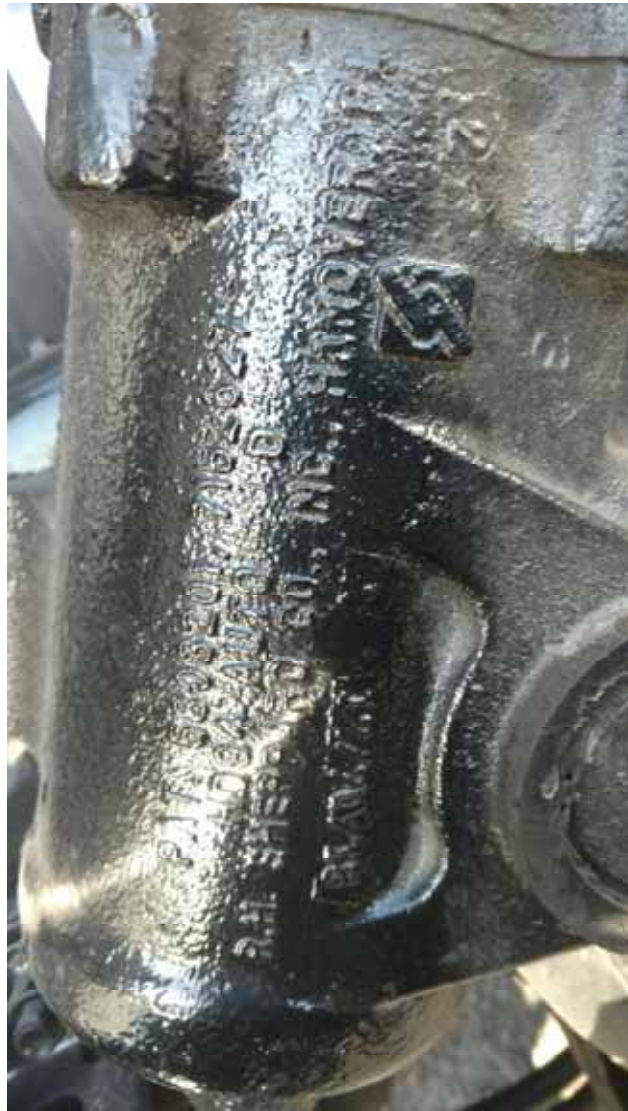
6. Locate the steering gearbox mounting fasteners – driver’s side frame rail.
7. Check all mounting fasteners (quantity of 3) for a relaxed torque:
 - a. Set torque wrench to 275 +/- 15 Nm (202 +/- 10 lb ft) and tighten until “CLICK” is heard.
 - b. If ANY fasteners move/rotate before reaching the relaxation torque, create a separate ARGUS Eservice case with all information and note the Recall in the case summary.
You must also include the steering gear casting information (photo ok), location shown below:
