Mercedes-Benz

Campaign No. 2009100018, November 2019

SUBJECT: **Model SL-class vehicles (231 platform)**  
**Model Year 2019**  
**Mounting of Rear Axle Carrier**

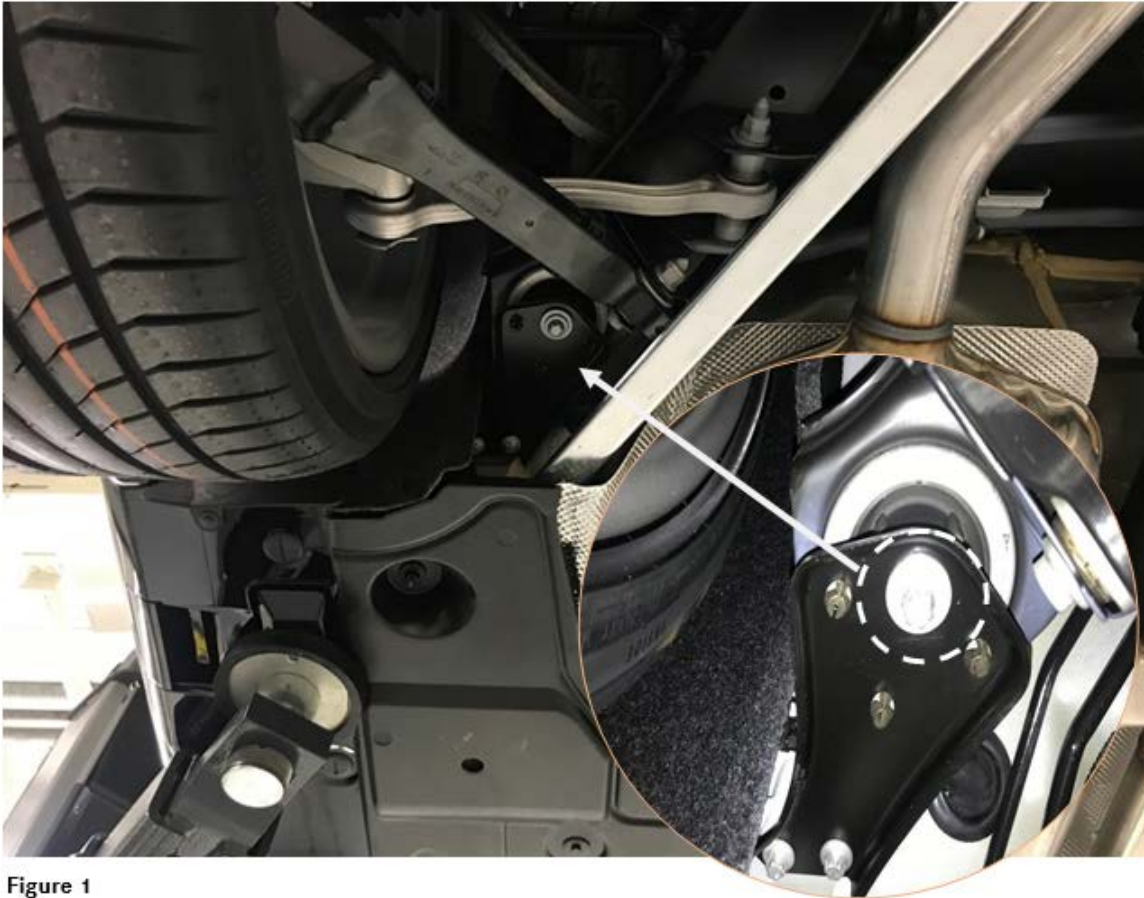
Figure 1

1. Lift vehicle with vehicle lift.
2. Unscrew the M12 screw on the front left rear axle carrier.  
 Secure the rear axle with the transmission jack.
3. Check thread with endoscope over the entire thread length.

- a. Thread Axle mounting (A) damaged: **Perform** work procedure.
- b. Thread Axle mounting (A) **not** damaged: **Replace bolt\*** and **End action**

\*for bolt installation see **BA35.10-p-1001-01N**

1. If the threads are damaged, create detailed pictures of the damaged threads and clarify further repair procedure using **PTSS-case**.  
 Submit PTSS-case via. Xentry portal
