Technical Service Bulletin

| GROUP RECALL | NUMBER 19-01-037H |
| DATE NOVEMBER, 2019 | MODEL(S) PALISADE (LX2) |

SUBJECT: 2020 PALISADE (LX2)
CURTAIN AIRBAG (RECALL CAMPAIGN 186)

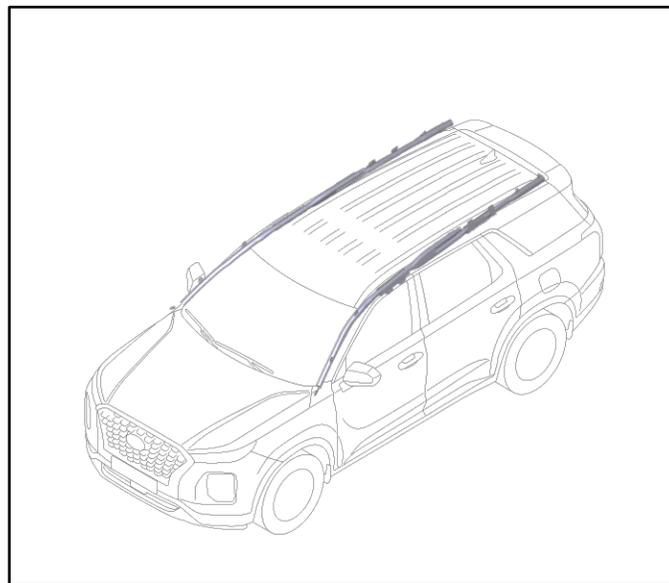
Certain Palisade (LX2) vehicles are equipped with curtain airbags that were installed using bolts that could interfere with and damage the airbags during deployment. If the curtain airbag becomes damaged during deployment, the airbag may not inflate properly during a crash, increasing the risk of injury.

This bulletin describes the procedure to install covering to the curtain airbag bolts to protect the curtain airbags in the event of inflation.

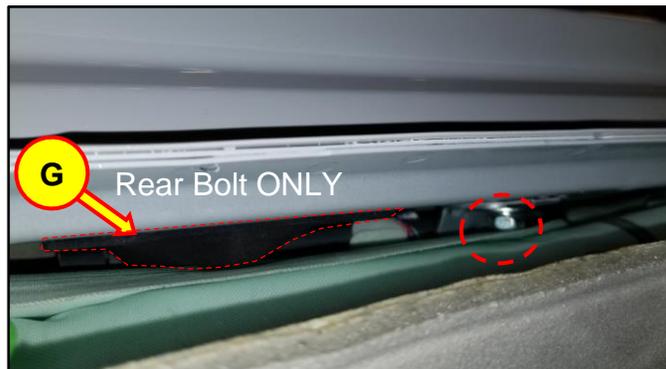
Rear bolt head must be fully covered by the pad. If not fully covered, the rear bolt head could damage curtain airbag during deployment.
