## Safety Recall Action Notice SB567 Issue 1 - 11.2019

Subject: Gear Linkage Clamp Assembly Replace				
Notice Number	Models Affected	VIN Range		Markets Affected
567	Speed Triple RS	From	898139	US and Canada Markets Only
		Up to	970149

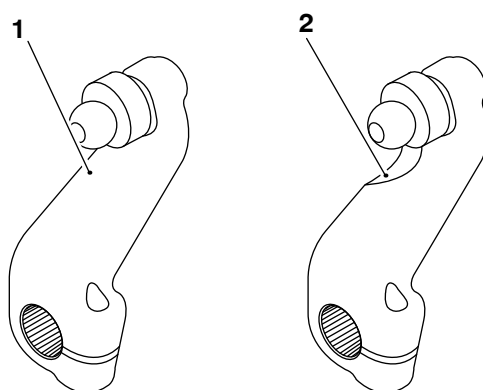
## Identification of Recalled and Remedy Parts

Internal investigations have identified a need to replace the gear linkage clamp assembly on the above model.

1. **Recalled part - Linkage clamp assembly, T2085085 (without scallop) - Referred to throughout as Gear Linkage Clamp Assembly**
2. **Remedy part - Linkage clamp assembly, T2085100 (with scallop) - Referred to throughout as Gear Linkage Clamp Assembly**

Dealers are required to replace the gear linkage clamp assembly as described in the procedure below.

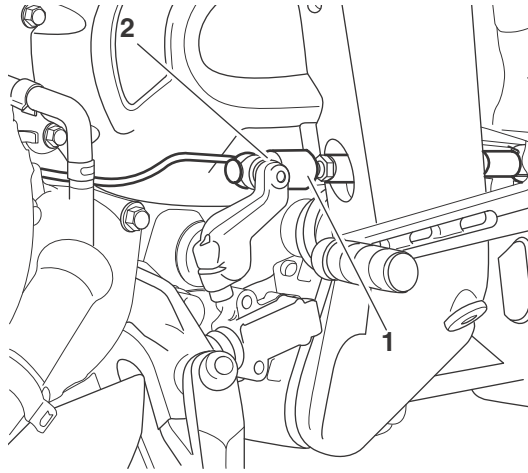
1. **TSA shift force sensor**
2. **Front wire clip position**

1. Remove the wire clip retaining the TSA shift force sensor front ball joint. Retain the wire clip for reuse.

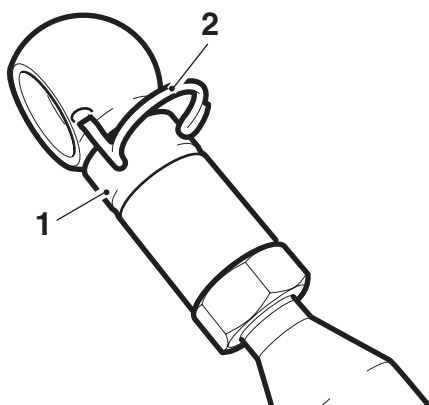
1. **TSA shift force sensor**
2. **Wire clip**

4. Refit the wire clip to retain the front ball joint. Make sure the wire clip locates correctly in the ball joint before rotating the clip to lock in place.
