Mercedes-Benz

Campaign No. 2020020021, March 2020

SUBJECT: **Model G-Class vehicles (463 platform)**
Model Year 2019
Routing of Door Wiring Harness

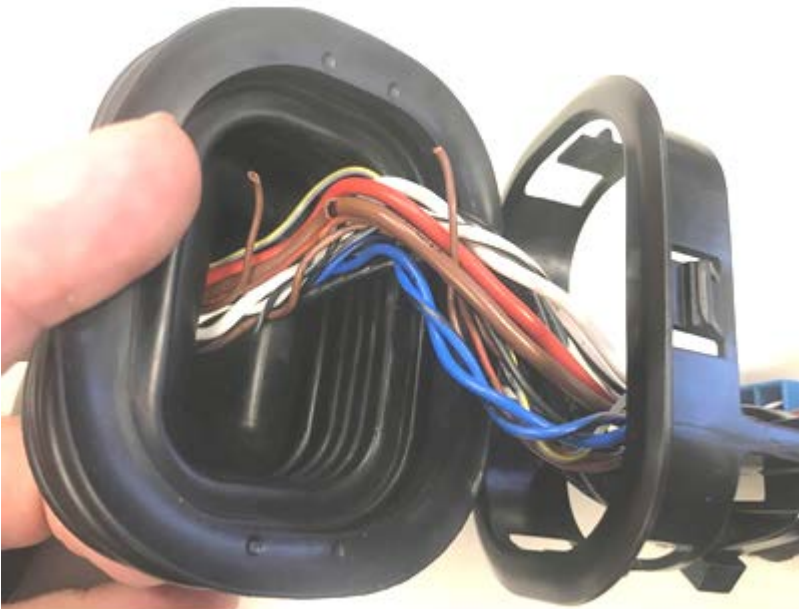
5. Check the wiring harness between the retaining frame and the door for damage.

i Figure 4 shows a state that is not OK.

Figure 4 NOT OK

- a. If the wiring harness **is not** damaged: Carry out **work procedure A**.
- b. If the wiring harness **is** damaged: Carry out **work procedure B**.
