SIB 65 23 19

2020-05-12

RECALL 19V-851: DRIVER'S FRONT AIR BAG (NADI) INFLATOR

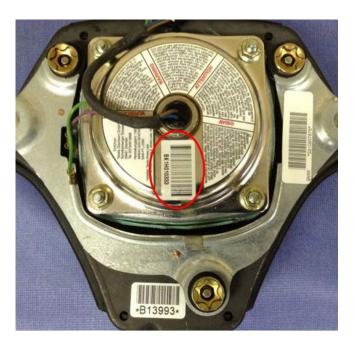
Basic Driver's air bag, showing the location of the parts label.

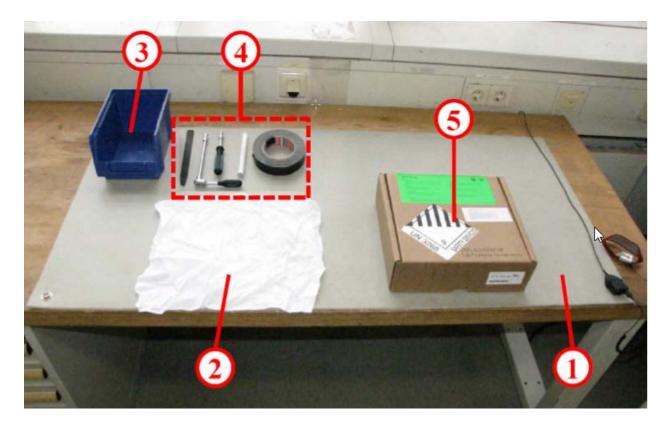
The workbench should be prepared with the following items:

- Anti-Static mat (1) which must be grounded (See SWS 2 06 04 (128))
- A soft blanket or material (2) to prevent damaging the air bag cover
- A container (3) for disposal of the original Generator nuts
- A packaged new part (5)

Tools required (4) for the Generator exchange:

- Plastic bone tool (SWZ 0 490 539)
- Ratchet with extension and 8 mm socket
- Small torque wrench with 8 mm socket (5 NM)
- Duct tape (.25 mm wide)

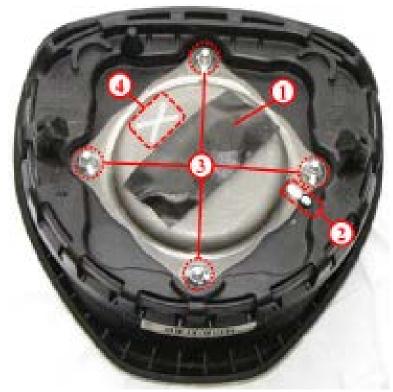
- Cover the connections on the old Generator with duct tape (1) so the contacts cannot be touched.
- Mark orientation (2) of the Generator in the Air Bag with the felt tip marker.

- Mark all four nuts (3) with the felt tip marker (to avoid mix up of old/new parts)
- Mark a large cross (4) with the felt tip marker (to avoid mix up of old/new parts)

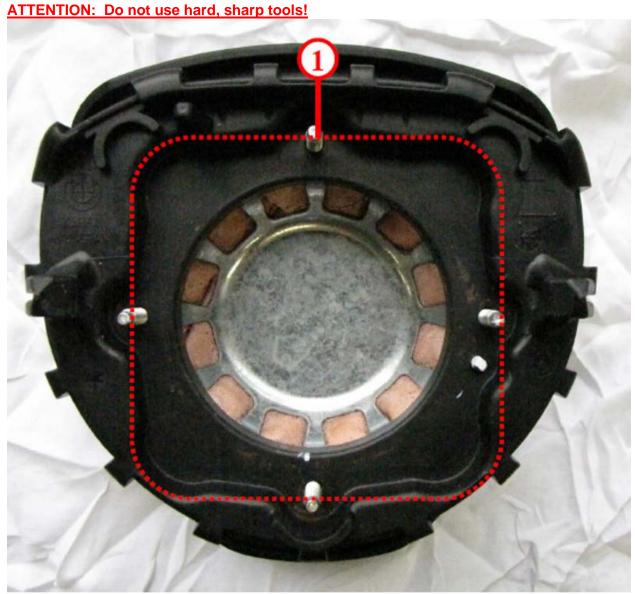
ATTENTION: In the area (1) above there must be no foreign objects!

There may be a small amount of surface rust on the metal within the air bag. This is normal.

Apply the four eyes principle and have this confirmed by two technicians.

- 1st Technician should perform a visual inspection of the air bag cavity for foreign objects.
- 2nd Technician should perform a visual inspection of the air bag cavity for foreign objects.

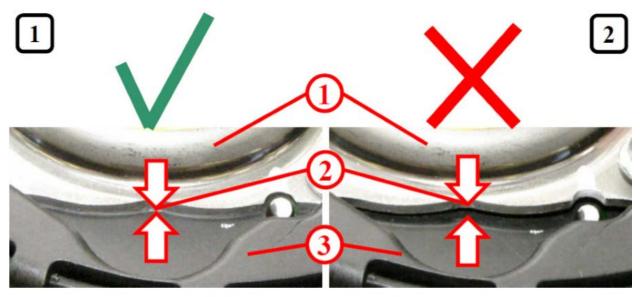
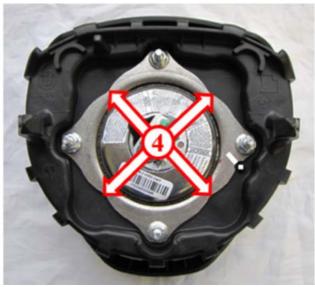
Perform a visual inspection of the gap (2) between the Generator (1) and the Air Bag (3) on all four sides of the Generator (4).

Picture (1) shows a correctly installed Generator

Picture (2) shows an improperly installed Generator with an excessive gap (2).

ATTENTION: If the gap cannot be closed up then cancel this procedure and replace the entire Air Bag assembly.
