SIB 65 24 19

RECALL 19V-852: DRIVER'S FRONT AIR BAG (NADI) INFLATOR

This Service Information Bulletin (Revision 2) replaces SI B65 24 19 dated December 4, 2019.

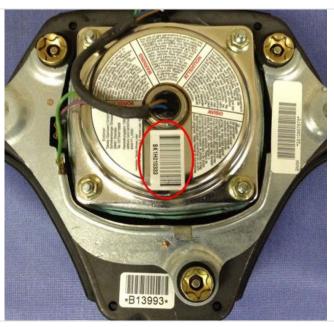
Once the air bag is removed and the wiring is disconnected, turn the air bag over to read the parts label(s) on the back.

Basic Driver's air bag, showing the location of the parts label.

Refer to the table below to see which category this air bag falls into. Descriptions of each category are shown below the table.
