SIB 65 06 20

2020-07-27

RECALL CAMPAIGNS 19V-852 AND 19V-853: DRIVER'S FRONT AIR BAG (NADI) INFLATOR

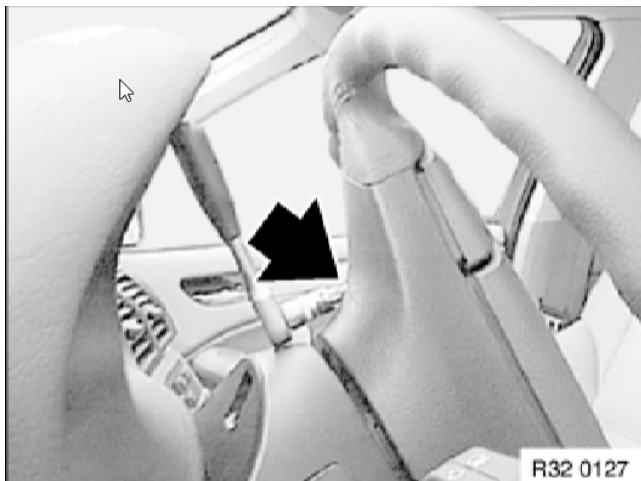
Remove **Basic Drivers air bag** as per

REP 32 34 020 "Removing and installing/replacing airbag unit"

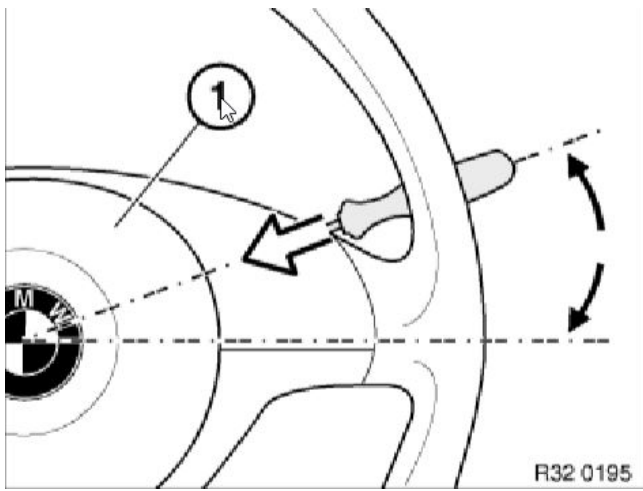
Remove **Sports Drivers air bag** as per

REP 32 34 020 "Removing and installing/replacing the airbag unit (sports steering wheel, inserted airbag unit)"
