PRODUCT CAMPAIGN BULLETIN

APPLICABILITY: 2019MY Ascent

SUBJECT: PCV Valve- Design Change

NUMBER: WUW-08R

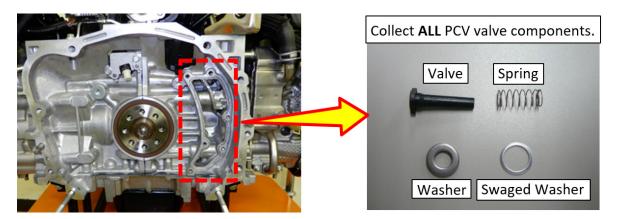
The PCV Valve on the affected models listed above may have been produced improperly. If the PCV Valve is broken, its internal components may have fallen into the engine. This may result in a large amount of white smoke from the tail pipe.

Step 2: Following the applicable Service Manual procedures, remove the oil separator cover and collect the PCV valve components (4 small parts) as shown in the photos below. If all four (4) of the PCV valve components cannot be collected after removing the oil separator cover, proceed with removing the oil pan to collect any remaining components.
