Safety Recall Code: 69Y5

Driver Frontal Airbag Inflator (Takata)

December 9, 2022

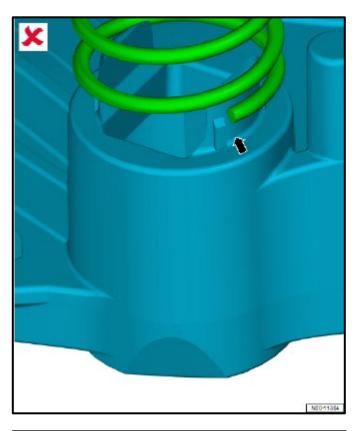
- If one of the springs is damaged or has been lost, it can be replaced with a spring from the bag of spares included.
- Note the examples shown for reference of proper spring seating.
- Spring seated incorrectly <arrow>.

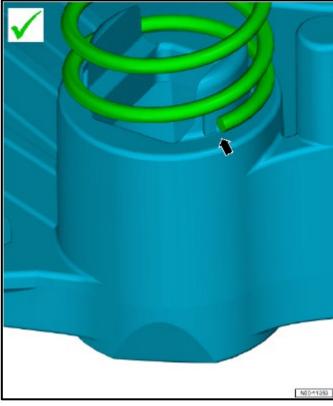
Spring seated correctly <arrow>.

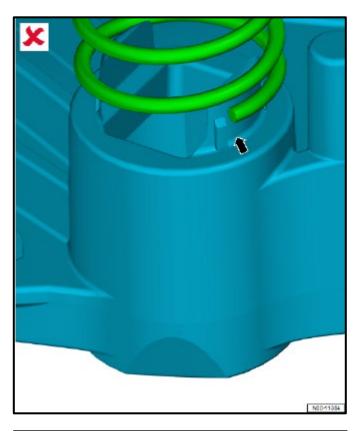
- If one of the springs is damaged or has been lost, it can be replaced with a spring from the bag of spares included.
- Note the examples shown for reference of proper spring seating.
- Spring seated incorrectly <arrow>.

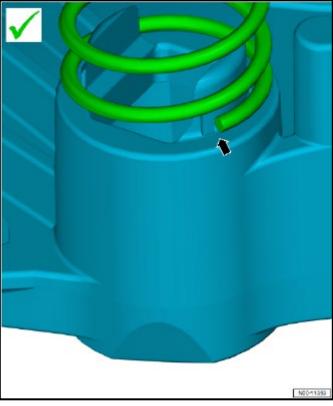
Spring seated correctly <arrow>.
