Field campaign

Topic	Power Assisted Steering - Pipe Union - Incorrect Dimensions (RE19/27)
Market area	Bentley: worldwide (2WBE),Hongkong-Macau (5HK)
Brand	Bentley
Transaction No.	2057135/1
Campaign number	RB41
Note	
Type	Recall Campaign
US code

Supersport - Supersport Convertible - Continental 24

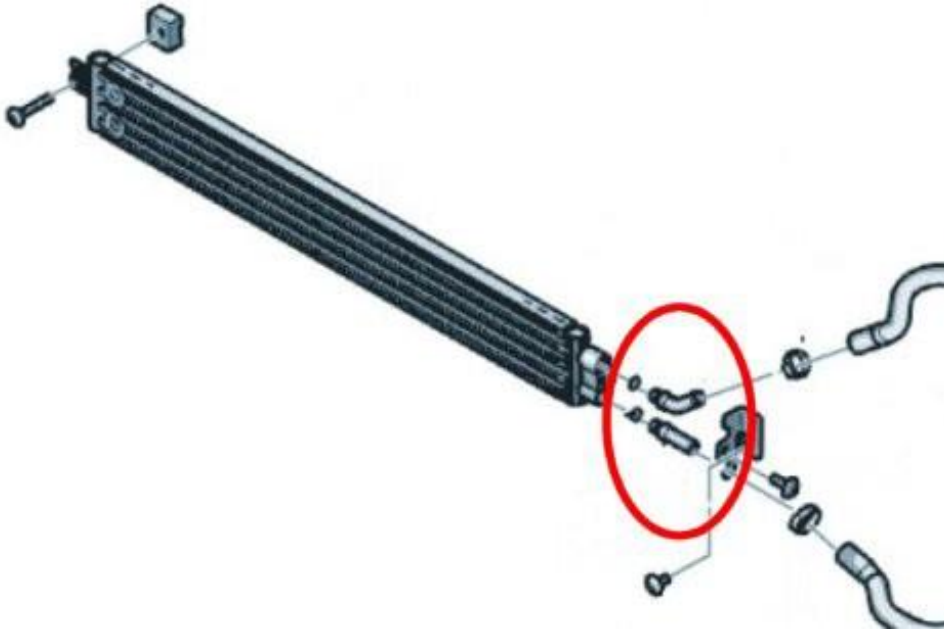
Two Power Assisted Steering (PAS) cooler stub pipes have been manufactured incorrectly. The fitting shape and dimension may not provide a robust mechanical seal, the associated hoses could therefore leak PAS fluid.

PAS cooler stub pipes with correct fitting shape and dimensions to be installed.

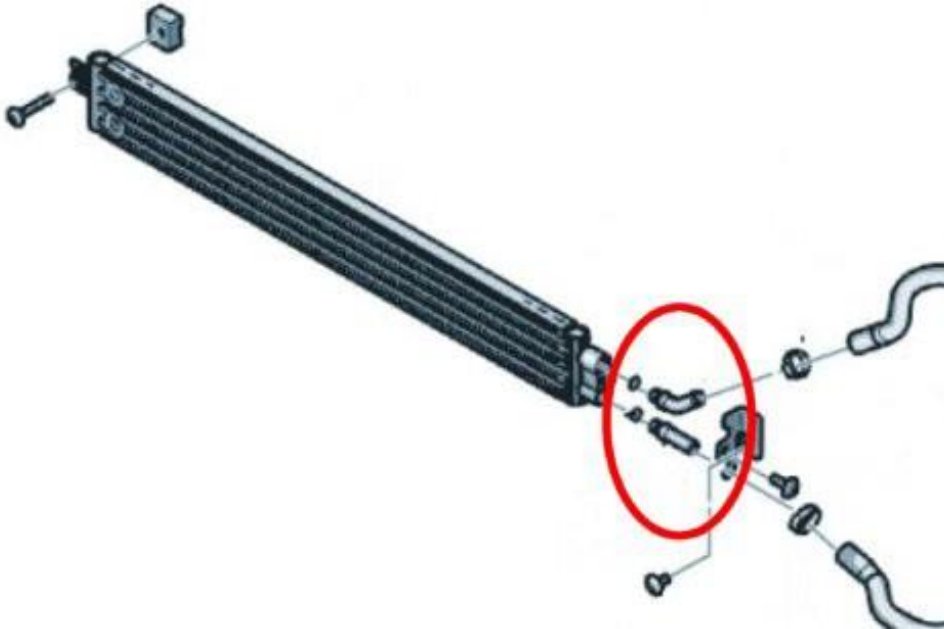
Two Power Assisted Steering (PAS) cooler stub pipes have been manufactured incorrectly. The fitting shape and dimension may not provide a

robust mechanical seal, the associated hoses could therefore leak PAS fluid.

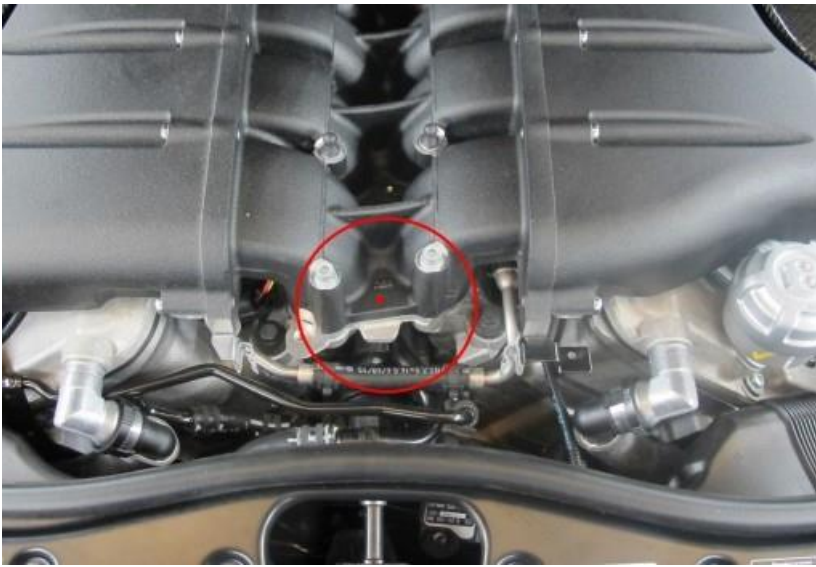
Figure 4

Red Campaign completion mark to the forward edge of the intake manifold – figure 4.
