SIB 12 30 19

## RECALL 19V-883: TRANSMISSION WIRING HARNESS

This Service Information Bulletin (Revision 3) replaces SI B12 30 19 **dated December 2019**.

## PROCEDURE A - Reposition the transmission wiring harness

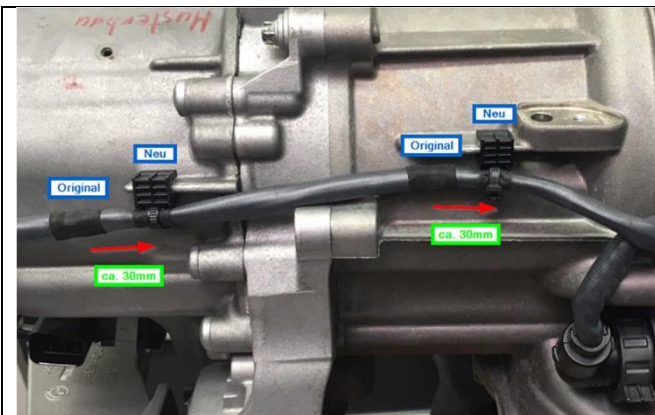
The cable strap location must be moved approximately 1 3/16 inches toward the front of the vehicle.

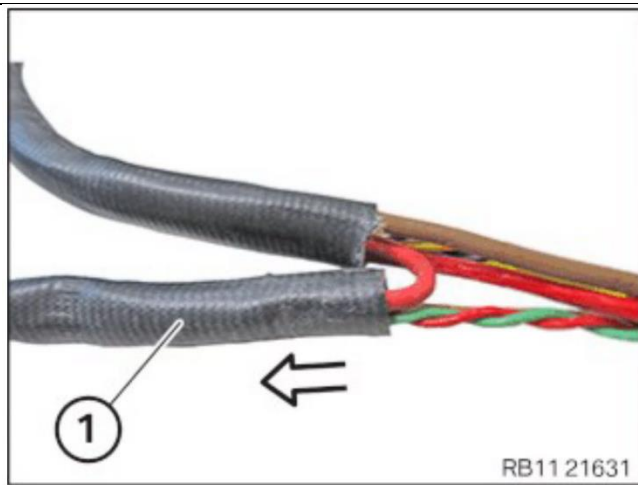
11. Check cable for damage.

10. Push insulating sleeve (1) back in direction of the arrow 110 mm (approximately 4 ½ inches).

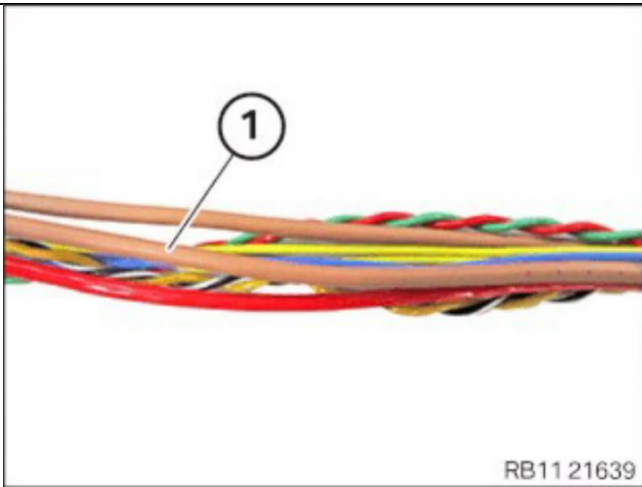
21. Check grounding cables (1) for damage and, if necessary, repair with an insulating sleeve.

Note: Do not perform steps 22 thru 27 if damage is not observed.
