SIB 12 30 19

## RECALL 19V-883: TRANSMISSION WIRING HARNESS

This Service Information Bulletin (Revision 3) replaces SI B12 30 19 **dated December 2019**.

### PROCEDURE A - Reposition the transmission wiring harness

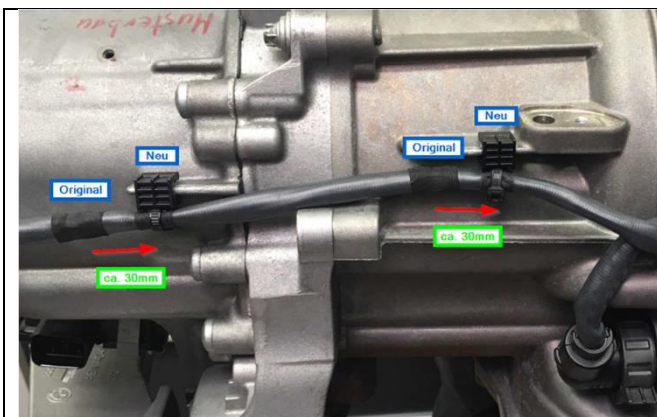
The cable strap location must be moved approximately 1 3/16 inches toward the front of the vehicle.

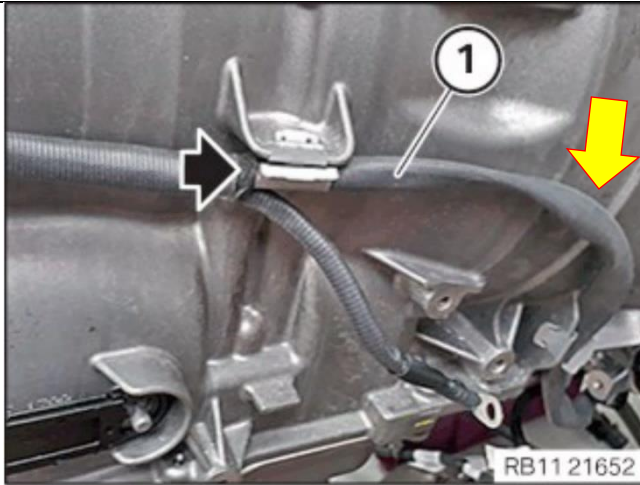
Note: Ensure enough slack (right arrow) so the harness is not pulled taught over the transmission housing casting lines.

20. Insert the transmission wiring harness (1; see graphic).

21. Secure transmission grounding.

Ground connection on the transmission  
Screw M6 x 12: Tightening torque 10 Nm.

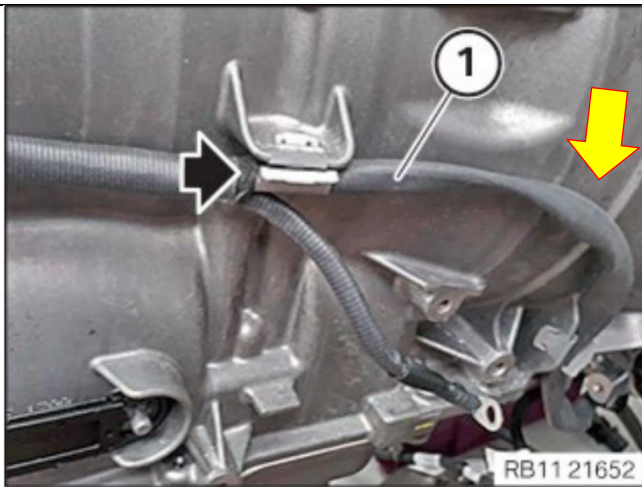
Note: Ensure enough slack (right arrow) so the harness is not pulled taught over the transmission housing casting lines.

40. Insert the transmission wiring harness (1).

41. Secure transmission ground lug. Ground connection on the transmission Screw M6 x 12: Tightening torque 10 Nm.
