SIB 12 30 19

2019-12-11

RECALL 19V-XXX: TRANSMISSION WIRING HARNESS

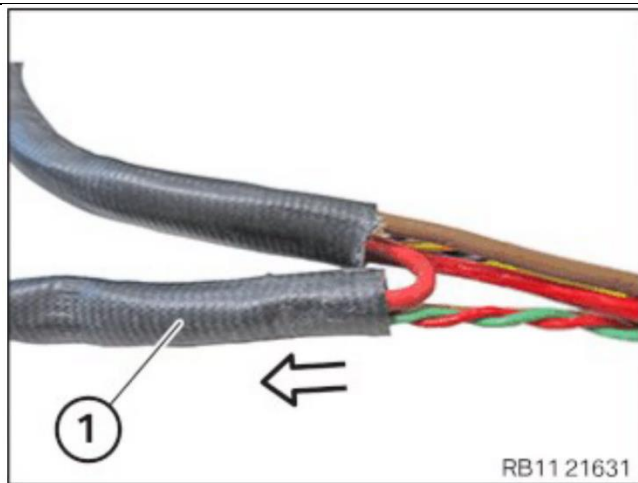
11. Check cable for damage.

10. Push insulating sleeve (1) back in direction of the arrow 110 mm (approximately 4 ½ inches).
