Dealer Service Instructions for:

Safety Recall VE2 / NHTSA 19V-886 Rear View Camera

2018-2019 (RU) Chrysler Pacifica

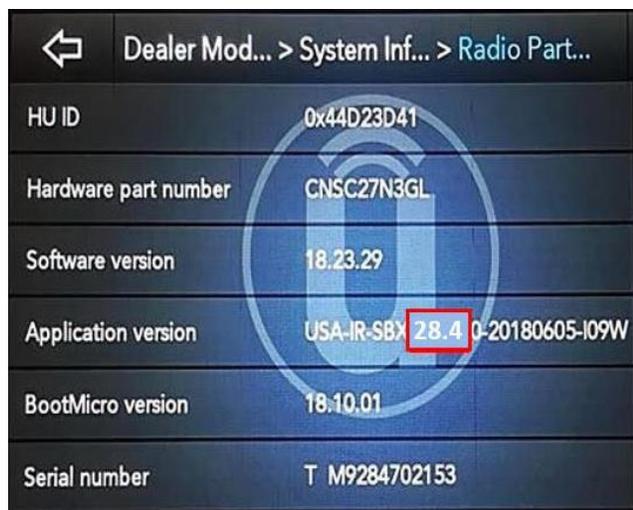
Figure 1 – Radio Software Level Screen

- a) Press and hold both lower corners of the display screen, until the Dealer Mode screen appears (approximately seven seconds). Release buttons.
- b) Select "Radio Part Information". The software level will be listed next to "Application Version" (Figure 1).

3. Is the radio software level (Application Version) at or higher than 28.4?
 - If YES, the radio software is already up to date. Return the vehicle to the customer.
 - If NO, proceed with the Repair Procedure.
4. Has a 16GB USB flash drive been created?
 - If YES, proceed to Step 12.
 - If NO, proceed to Step 5.

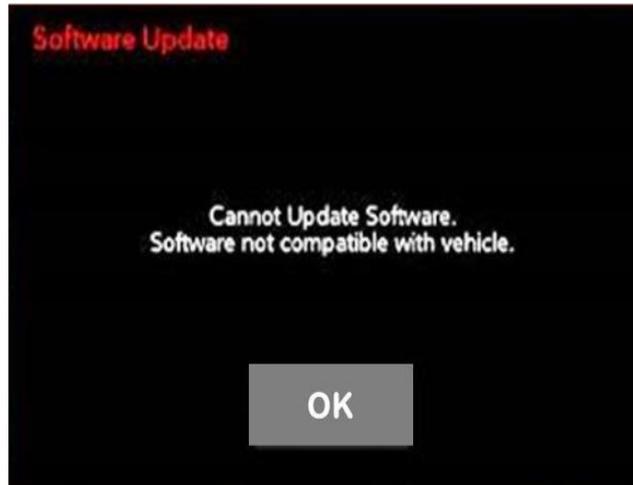
Figure 5 – Software Not Compatible

- 13. If the screen in (Figure 5) is displayed, the USB flash drive was not set up correctly. Use a top name brand USB flash drive like Kingston and create a new flash drive and start the update again.

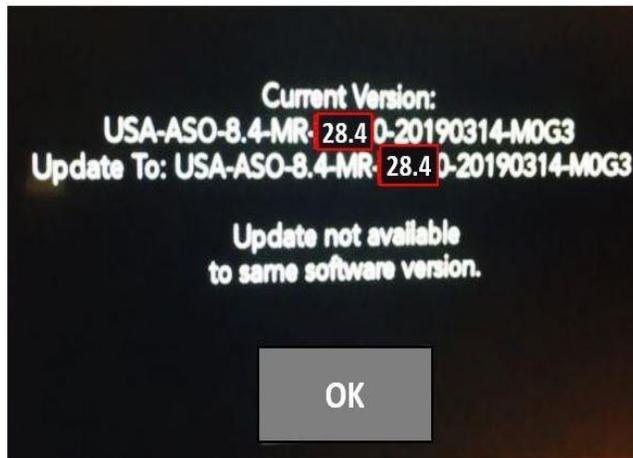
Figure 6 – Radio Software Already Up To Date

- 14. If the radio software is up to date, the screen in Figure 6 will be displayed. Press "OK" and remove the USB flash drive (Figure 6).

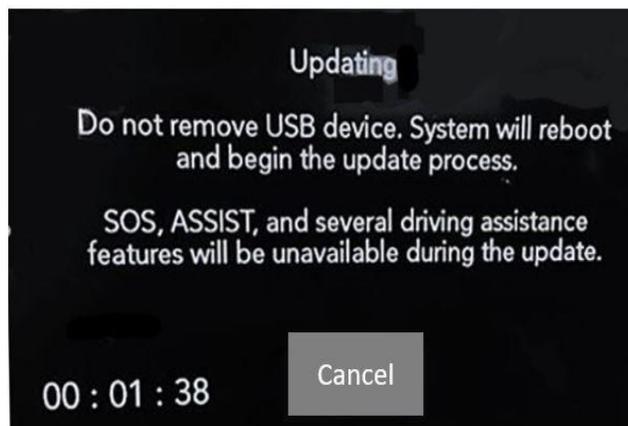
Figure 8 – Radio Update Process Begins

16. When the radio starts updating, this screen will be displayed (Figure 8).

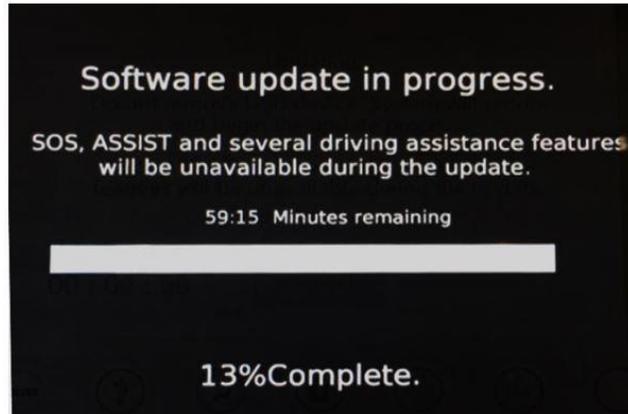
Figure 9 – Software Update In Progress

17. The radio will reboot and the update will begin. The update will take approximately 30 minutes, though the timer on the screen may display the incorrect time remaining.

NOTE: The completion indicator may not reach 100%, even though the software update has been completed. Once the software update has finished, the radio and display screen will turn off (Figure 9).

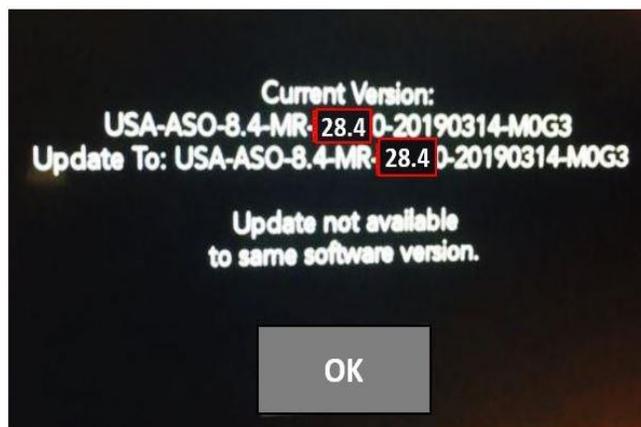
Figure 10 – Software Levels

18. After the update has completed, the radio will shut down. With the USB flash drive still inserted in the USB port, turn the ignition back to the run position. If the radio has been updated correctly, the screen in Figure 10 will be displayed. Press “OK” and remove the USB flash drive (Figure 10).
