## PRODUCT CAMPAIGN BULLETIN

**NUMBER:** **WUX-09R**

**SUBJECT:** 2016-2017 Outback Replacement  
Airbag Control Module

**NHTSA ID:** 19V910

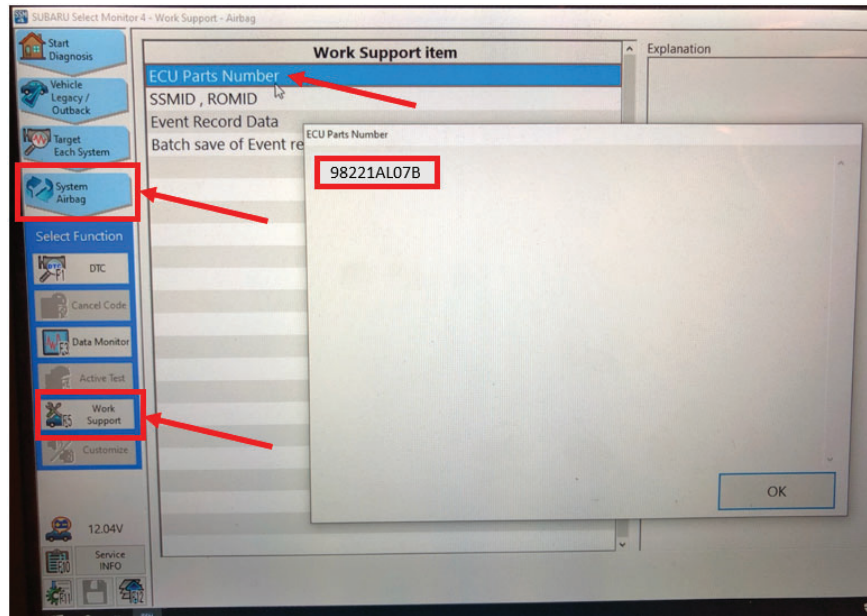
**Step 1:** Inspection: Using the Select Monitor, select: Each System > Airbag > Work Support > ECU Parts Number, to confirm the part number of the currently installed Airbag Control Module as shown below.

- If the Part Number is **98221AL07B**, proceed to **Step 2**.
- If the part number is **NOT 98221AL07B**, the vehicle is **NOT AFFECTED** by this recall. **IMPORTANT:** Record the ECU part number on the repair order as this will be required for claim submission. Proceed to the CLAIM REIMBURSEMENT AND ENTRY PROCEDURES section and process a claim for **Inspection Only**.

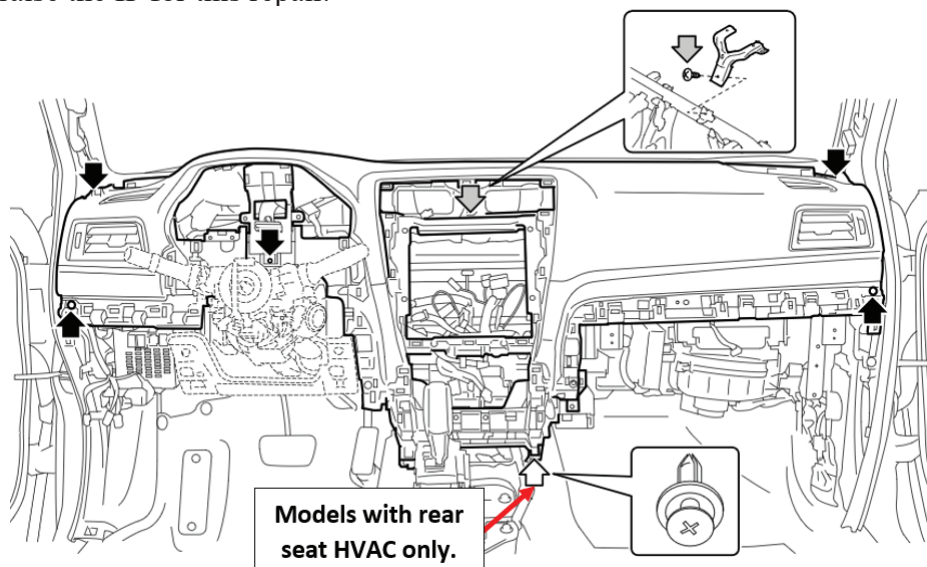
**Step 2:** The Service Procedure for replacing the passenger's side front airbag module utilizes the currently applicable Service Manual steps (excluding Step 2, seat removal) up to and including Step 16. At that point, the instrument panel (IP) should be loosened but **NOT** removed. The illustration below shows locations of the IP retaining screws. All these screws must be removed before attempting to raise the IP for this repair.

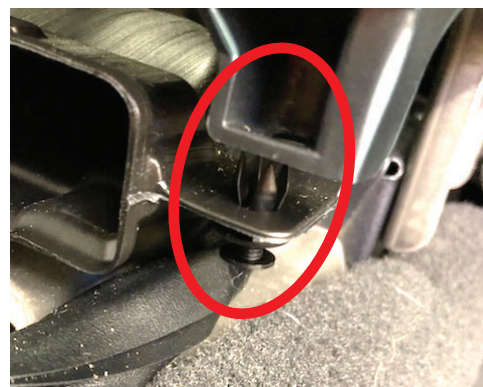
**NOTE:** On models with rear seat HVAC (air vents on the back of the console box), in addition to an air duct running past the shifter, there is a clip under the storage box on the right side at the base of the IP securing the rear seat area ventilation duct which must be removed. Models without rear seat HVAC do not have this clip or the air ducts.

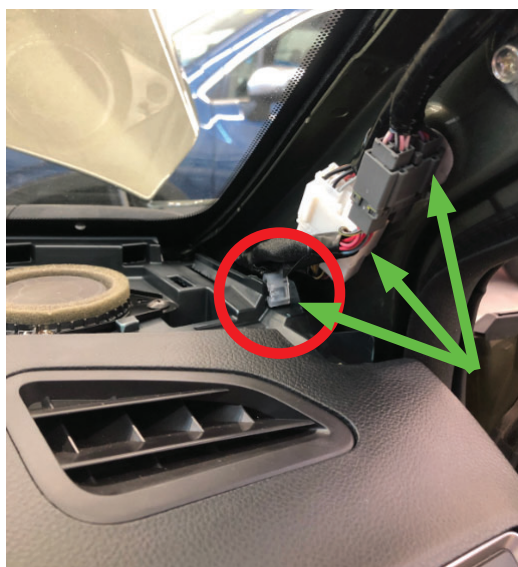
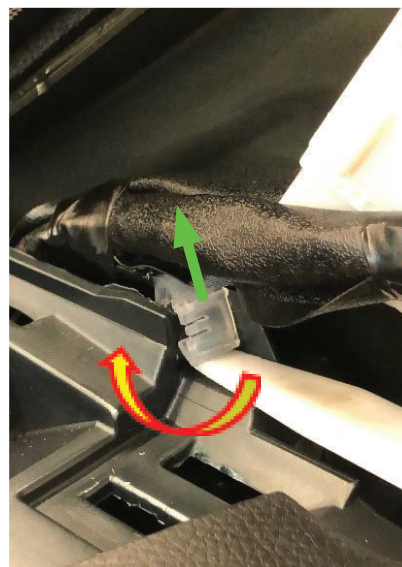
- **CAREFULLY** remove both “A” pillar trims with a plastic trim tool and disengage the tether clips at the top of each panel. After removing the IP speaker grille, twist / disengage the retaining clip for the wiring harness from the IP as shown in the photos below. Use a trim clip removal tool to disengage the retaining clips for the 2 harness connectors secured to the “A” pillar.

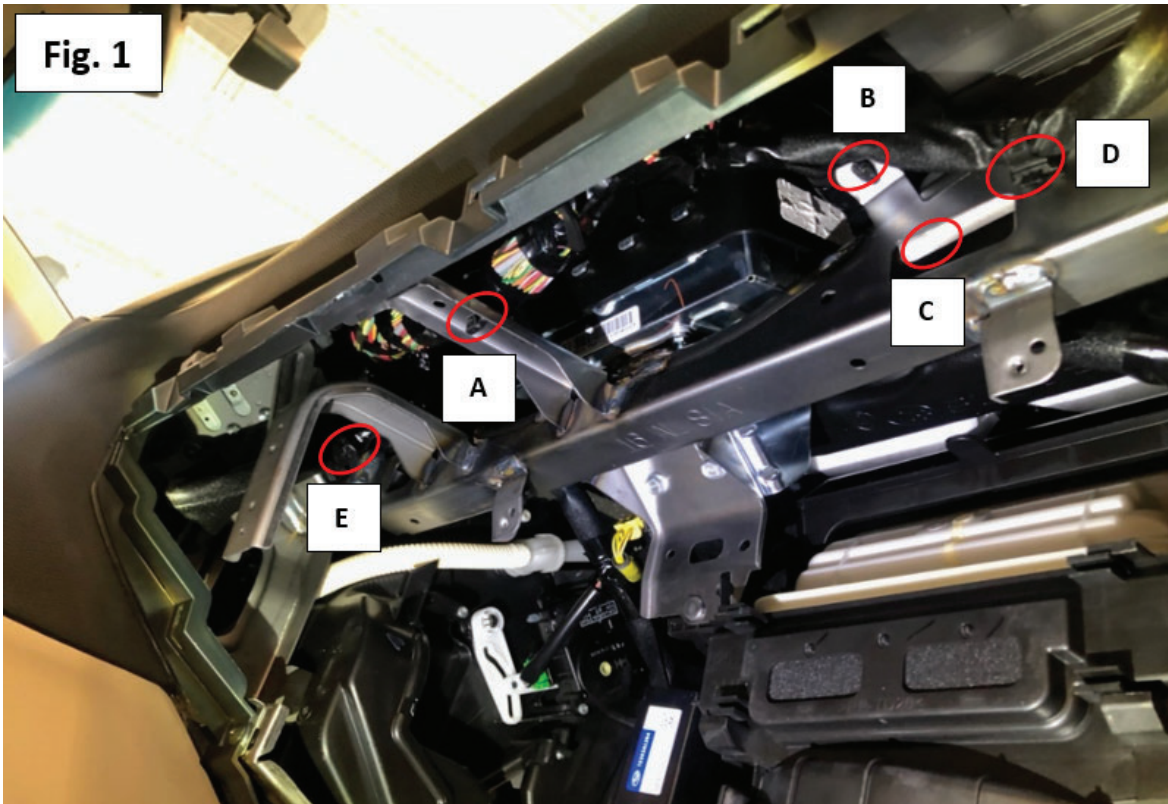
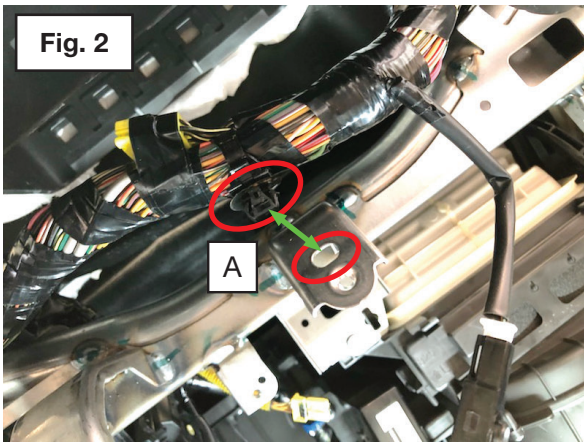
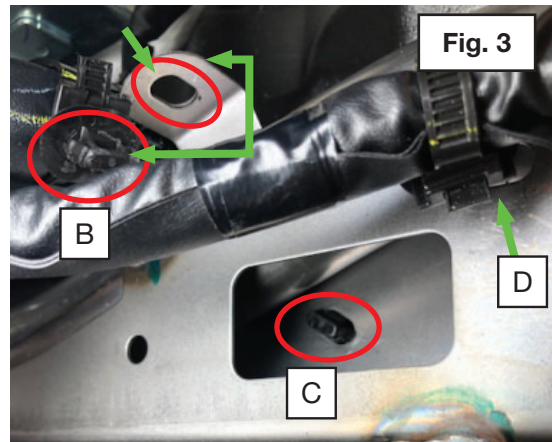
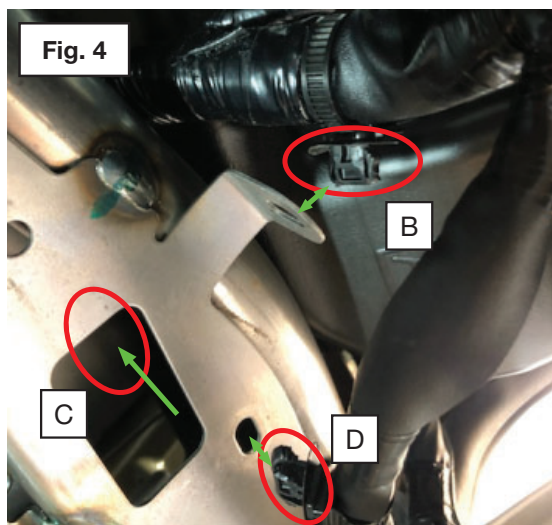
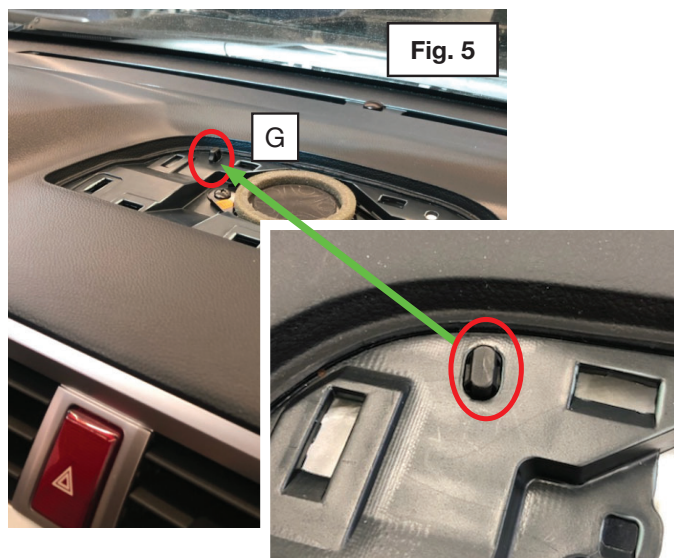
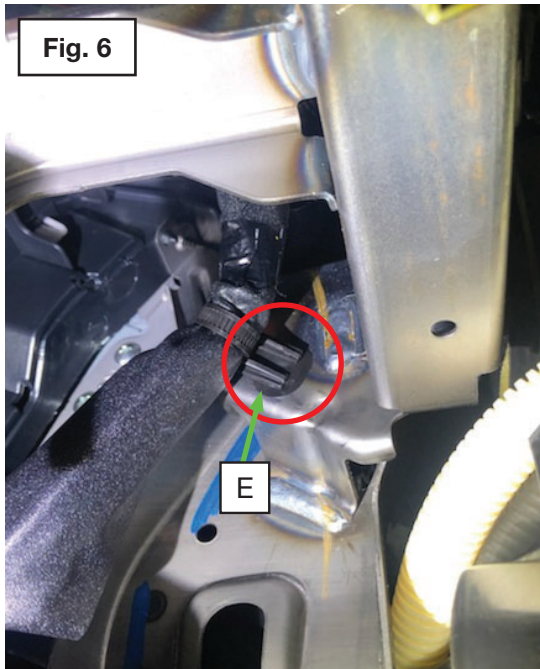
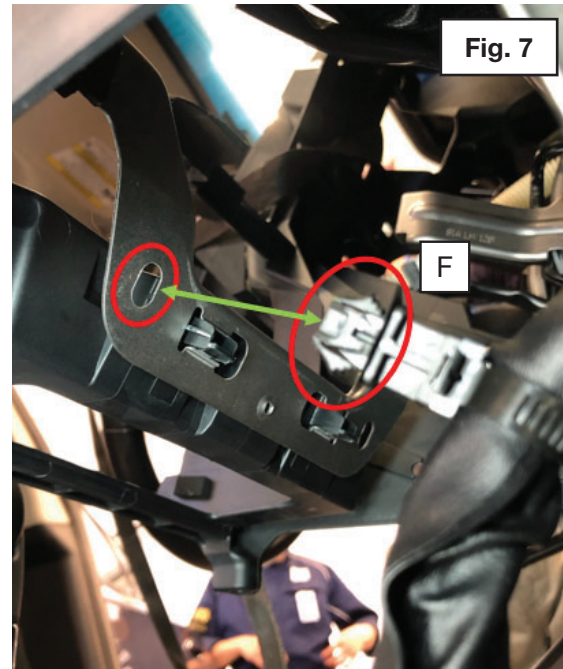
- **CAREFULLY** release the plastic retaining clips securing the IP wiring harness in the 7 locations shown below using a needle-nosed plier or trim clip removal tool. Use the overall photo (**Fig. 1**) shown below for clip location reference and the rest of the photos for specifics. Releasing these clips provides additional access to get the airbag module past the harness. **Fig. 2** shows clip **A** on a brace adjacent to the airbag module. **Figs. 3** and **4** show the same clips (**B, C & D**) but the photos were taken from different angles.

**Fig. 5** shows clip **G** under the IP top center speaker grille. **Figs. 6 & 7** show clips **E & F** securing the harness to braces in the center of the IP near the storage box below the audio unit and HVAC controls.

**IMPORTANT NOTE:** Since clip **D** is not accessible from behind to release it and will most likely be damaged during removal, a replacement is included in the box along with the new replacement airbag module.

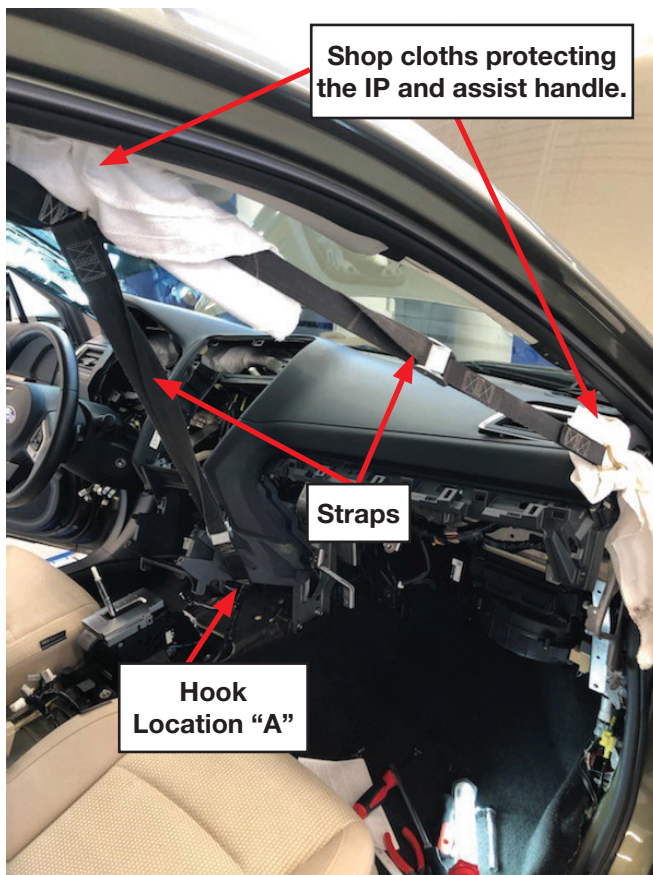
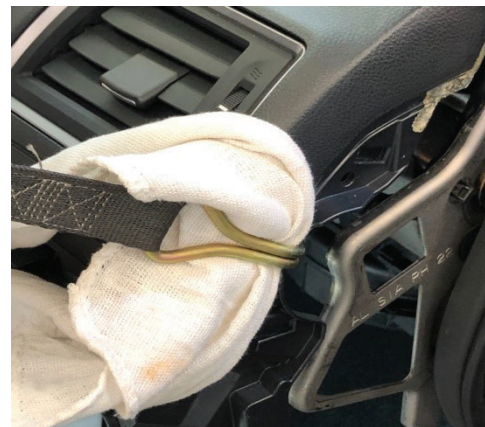
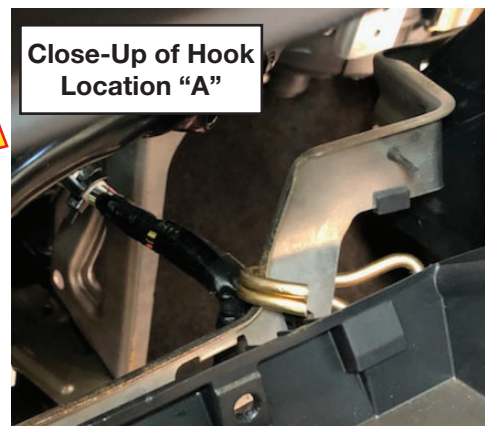
The procedure shown below utilizes 2 generic, readily available tie-down straps in place between the IP and the passenger assist handle to hold the right side of the IP elevated while removing and reinstalling the airbag module.

**VERY IMPORTANT:** Always protect the IP and assist handle from the strap hooks with clean shop cloths (or equivalent). Recommended positions for the hooks are shown in the photos below. Hook location “A” is on the right side of a metal IP support bracket near the center storage box.
