Subject: Tag Axle Lock Clamps Rework			
Field Change Program: Field Campaign	FCP Number: 477	Revision: A	Date: MM/DD/YYYY
Coach Section: 12- Suspension	P/N: 12-04-1253		Type: Safety Recall

Ref. NHTSA Recall No.: 19V-924	Ref. Transport Canada Recall No.: N/A
--	---

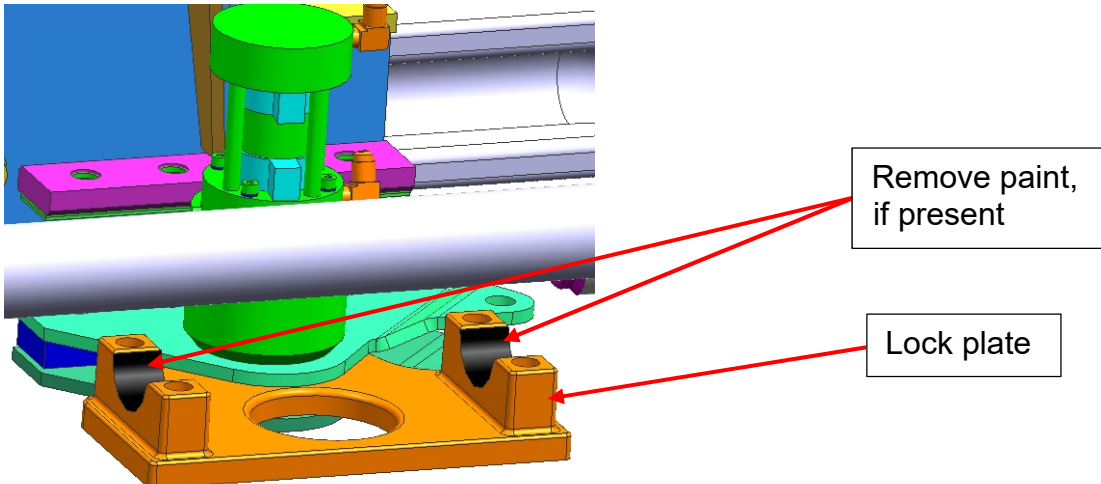
The causes of the insufficient clamping were determined to be (1) the clamp blocks having paint on the clamping surfaces, (2) the fastener surfaces on the clamp blocks not being machined, and (3) the fastener head surface not being perpendicular to the tie rod clamping surface. The combination of paint on the clamping surface and the fastener head side loading allowed the clamp fasteners to lose torque. This allowed the tie rod to slide in operation when under load. Movement of the tie rod within the lock clamps allowed the tag axle to be offset from the front steering axle.

Slide the lock assembly and lock plate down and observe for paint on the lock plate at the location illustrated below. If paint is observed on the surface of the lock plate that clamps the tie rod, use an abrasive paper to remove the paint in that area.
