Product Safety Recall

N192261860 Tonneau Cover Retention

Release Date: January 2020

Revision: 02

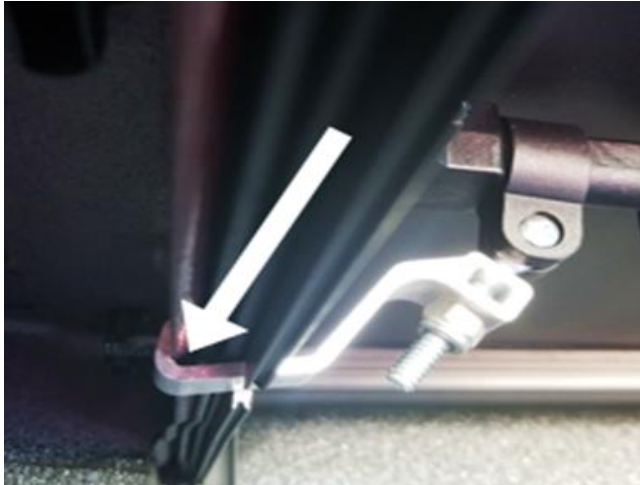
5448624

Correct installation of bracket clamp hook

8. Verify the tonneau clamp hook is outboard of the metal bed side and not between the metal and plastic bed rail trim.

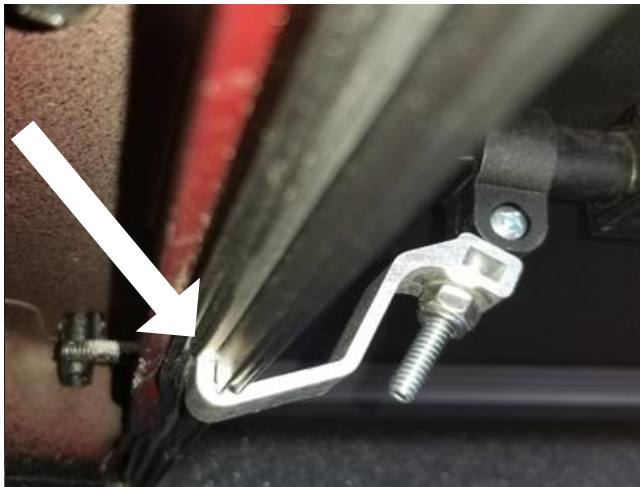
5448625

Incorrect installation of bracket clamp hook

9. If any of the above inspections indicate an incorrect clamp hook installation, loosen the nut on the threaded mount and position the clamp hook in the correct position. Hand tighten the fasteners.
10. Position the cover evenly side to side and rest the cab seal smoothly along the front top edge of the cargo bed.
11. Tighten the nuts until the clamp hooks are secure against the bed rail flange. Tighten each side evenly, tighten only until the tonneau cover cannot shift. **DO NOT** overtighten, overtightening may cause damage to the clamping system.
12. Close the tonneau cover and tailgate.
