DATE: September 21, 2020
TO: Blue Bird Owners
Subject: RECALL R19AF, Safe Fleet Prolo Roof Hatch Handle

NHTSA Recall Number: 19V-526 (School Bus)
NHTSA Recall Number: 19V-524 (Non-School Bus)

SUBJECT: RECALL R19AF, Safe Fleet Prolo Roof Hatch Handle

OUTER HANDLE REPLACEMENT

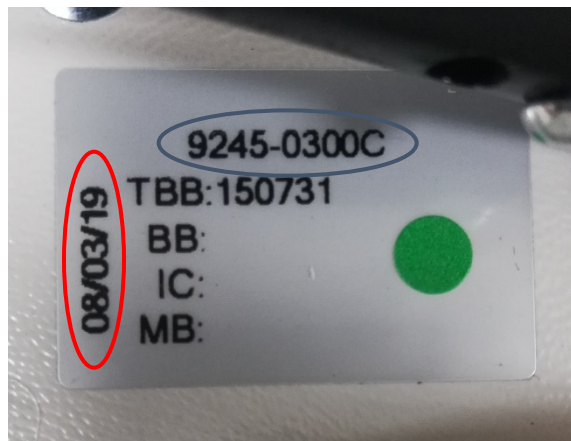
1. Check the label on the bottom of the Prolo Hatch p/n 92XX-XXXXX (circled below in blue) for dates between August 1, 2018 and May 20, 2019 (circled below in red). Units built within this date range are subject to the replacement campaign.

Replacing the outside release handle will resolve the defect. The replacement kit will include (1) replacement handle, associated hardware, and replacement instruction information.

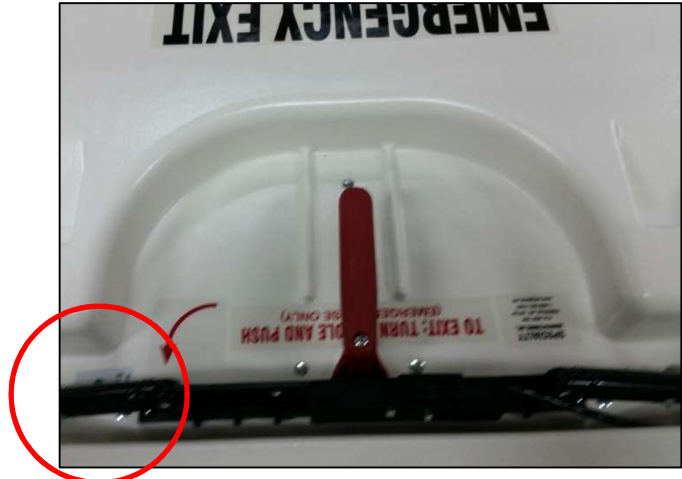
Step 2. Locate the silver "build date" sticker on the inside of the lid (located in red circle shown above)
