R19AF

ADDITIONAL FINAL NOTICE

DATE: May 19, 2022
TO: Blue Bird Owners
Subject: RECALL R19AF, Safe Fleet Prolo Roof Hatch Handle

IMPORTANT SAFETY RECALL NOTICE

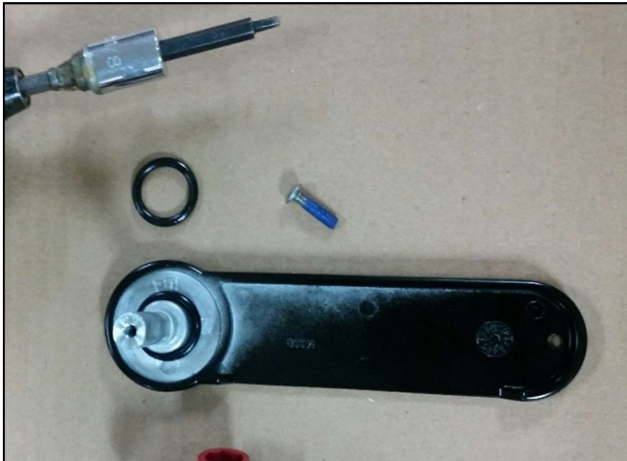
Step 1: Gather the necessary components for the work. 009336 Handle, 009321-5 O-ring, 008798 Screw, 1/8" Allen wrench or driver w/ 1/8" bit

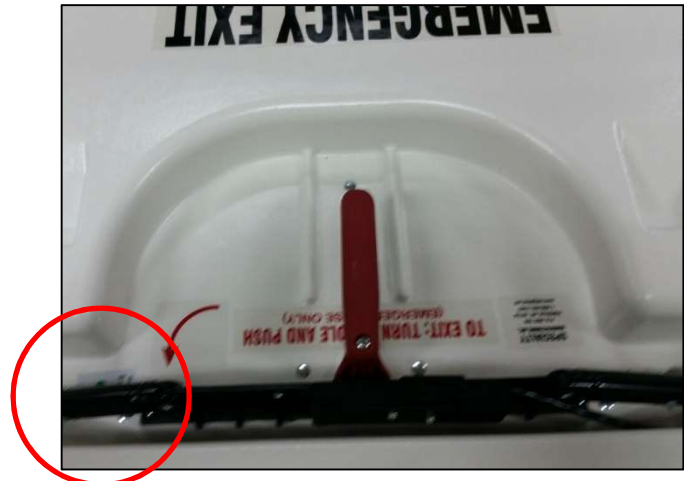
Step 2. Locate the silver “build date” sticker on the inside of the lid (located in red circle shown above)

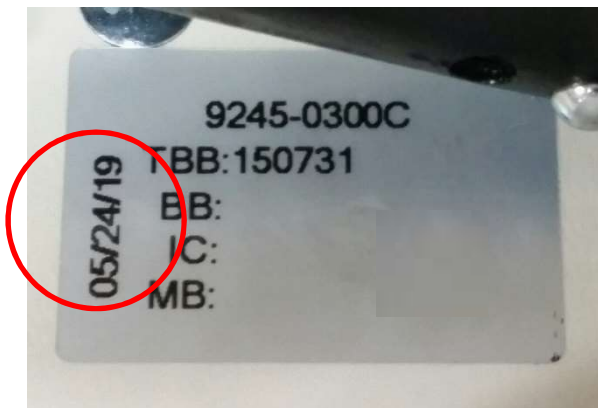
Step 3: If the date is between 8-1-18 and 5-21-19, the hatch will need to be reworked. Dates before or after that timeframe do not need rework.

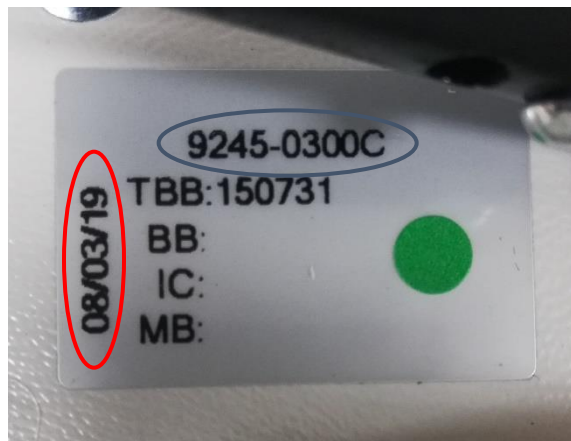
SMI has determined that some Prolo Hatches may contain defects (voids/porosity) in the outside release handle that have resulted from the casting process. Excess voids and porosity may create failure points in the handle that can lead to breakage under reasonable use. Failure of the external release handle will prevent the hatch release mechanism from being actuated from outside the vehicle. The hatch can still be opened from the outside by venting the hatch and actuating the inside release handle however this operation is not intuitive and not detailed in the required instructions located on the hatch. Failure of the external release handle does not prevent actuation of the release mechanism from inside the vehicle.

1. Check the label on the bottom of the Prolo Hatch p/n 92XX-XXXXX (circled below in blue) for dates between August 1, 2018 and May 20, 2019 (circled below in red). Units built within this date range are subject to the replacement campaign.

Replacing the outside release handle will resolve the defect. The replacement kit will include (1) replacement handle, associated hardware, and replacement instruction information.
