Subject: RECALL R19AH – Joint Strength Noncompliance – Insufficient Roof Rivet Quantity

NHTSA Recall Number: 19V-707 School Bus

R19AH – Insufficient Roof Rivet Quantity

Models Affected: Certain 2019-2021 Vision and All American buses

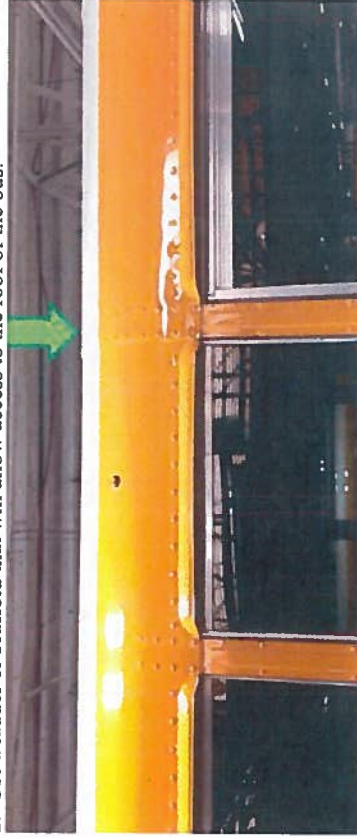
1. On one side of the bus, starting at either the front or the rear, go to the first roof panel joint seam of double rivets. These will be the rivet rows that need to be inspected.
2. Use a ladder or scaffold that will allow access to the roof of the bus.

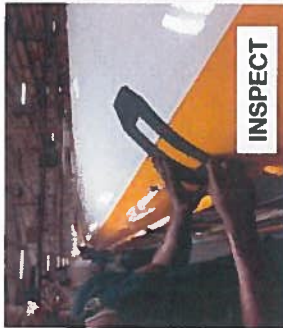
INSPECT

3. Inspect rivet spacing at each roof sheet joint. Roof sheet joints are assembled with two rows of rivets. Joint must have a minimum of six rivets in an eight inch segment. The full length of the roof sheet joint, including the top of the bus, must be inspected and corrected, if needed.

- a. Place the supplied rivet spacing template over the joint and parallel to the edge of the roof sheet, allowing roof rivets to be exposed through the opening in the template, as shown.

- b. Move the template from one side of the roof sheet towards the center of the roof.
 - c. If a segment in the roof joint contains less than six rivets, additional rivets are required. Mark each area that requires additional rivets.
