Equipment Safety Recall

N192217500 Tonneau Cover Retention

Release Date: July 2019

Revision: 03

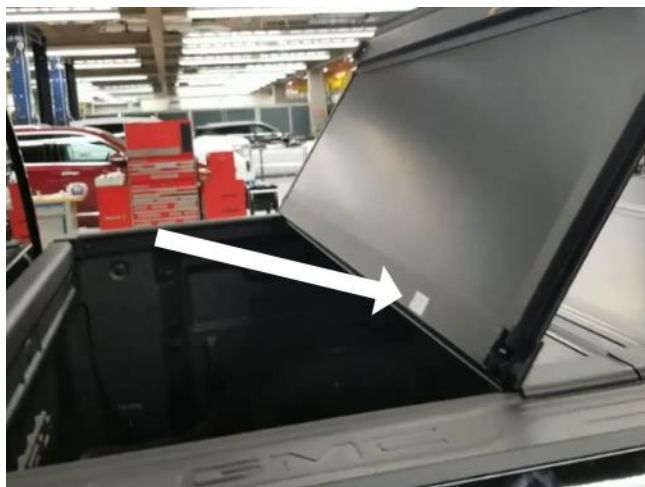
5368714

1. Inspect the tonneau label (located under driver front folding panel) for part number.
2. If label has PN 84679033 or 84679034, no additional rework is required. Parts are updated with latest service field fixes by the supplier. Use labor code 9104553, Inspection – No Further Action Required to close out the VIN.

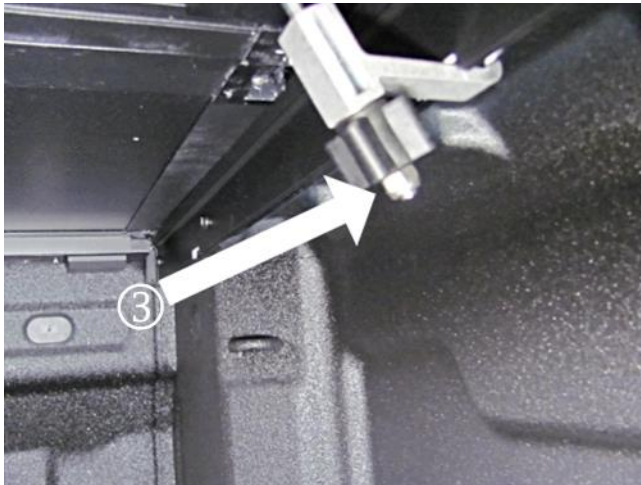
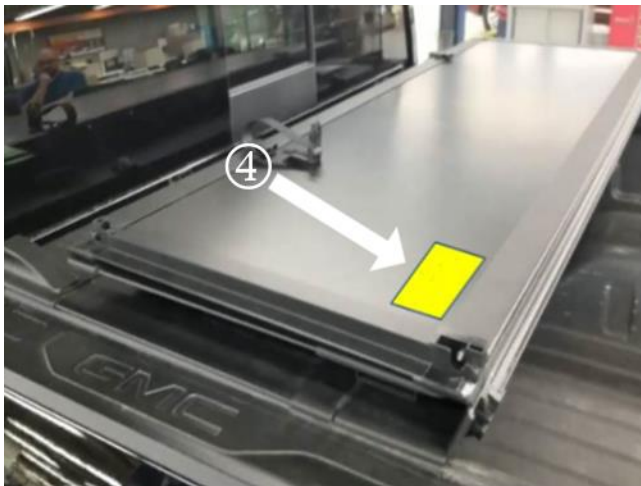
3. If label has PN 84060327 or 84060328, ensure tonneau has service attachment kit PN 84767027 installed. The tonneau front panel will have a lip seal (1) rather than bulb seal (2), a thumbwheel and hex nut for each clamp (3), and warning labels (4) attached if attachment kit is installed. If all components are present, use labor code 9104553, Inspection – No Further Action Required to close out the VIN.
