# Product Safety Recall

## N192261860 Tonneau Cover Retention

**Release Date:** January 2022

**Condition** General Motors has decided that a defect which relates to motor vehicle safety exists in certain soft tri-fold tonneau covers sold as accessories/aftermarket parts for 2019 – 2020 model-year Chevrolet Silverado and GMC Sierra 1500 series light duty trucks. If not correctly installed according to the instructions provided with the vehicle in an owner’s manual insert, the tonneau cover may become loose and could detach from the pickup bed while driving. If the tonneau cover detaches from a moving vehicle and falls into a roadway, it may increase the risk of a crash.

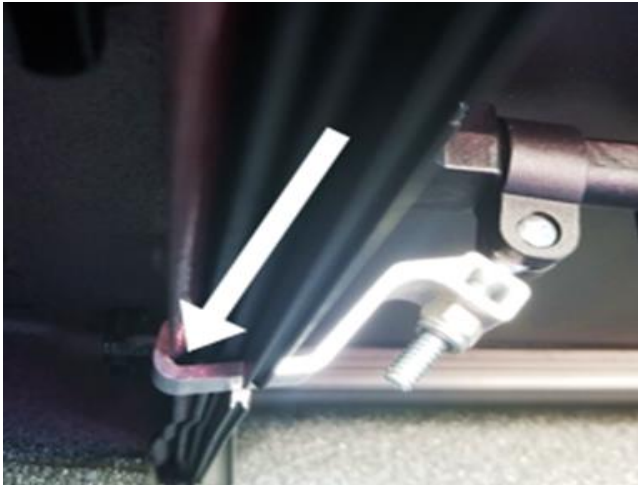
5448624

**Correct installation of bracket clamp hook**

8. Verify the tonneau clamp hook is outboard of the metal bed side and not between the metal and plastic bed rail trim.

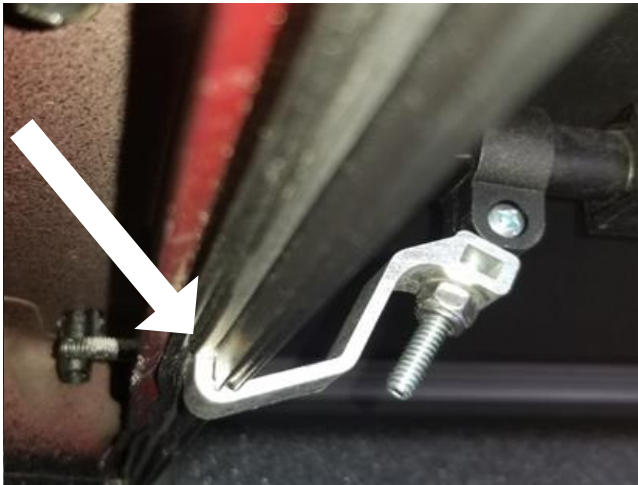
5448625

**Incorrect installation of bracket clamp hook**

9. If any of the above inspections indicate an incorrect clamp hook installation, loosen the nut on the threaded mount and position the clamp hook in the correct position. Hand tighten the fasteners.
10. Position the cover evenly side to side and rest the cab seal smoothly along the front top edge of the cargo bed.
11. Tighten the nuts until the clamp hooks are secure against the bed rail flange. Tighten each side evenly, tighten only until the tonneau cover cannot shift. **DO NOT** overtighten, overtightening may cause damage to the clamping system.
12. Close the tonneau cover and tailgate.
