# Product Safety Recall

## N192261860 Tonneau Cover Retention

Release Date: December 2019

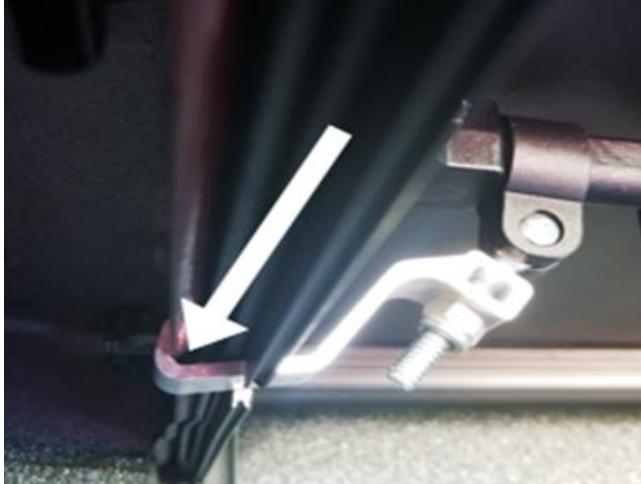
5448624

**Correct installation of bracket clamp hook**

6. On both sides of the cargo box, verify the fore-aft location of the front cross bar tonneau clamp hooks. Ensure the clamp hooks are fully seated and secure in the rectangular tonneau rail location notch.
7. Verify the tonneau clamp hook is outboard of the metal bed side and not between the metal and plastic bed rail trim.

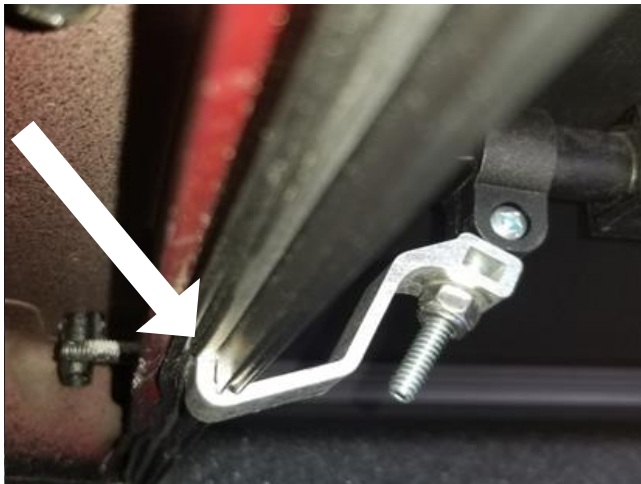
5448625

**Incorrect installation of bracket clamp hook**

8. If any of the above inspections indicate an incorrect clamp hook installation, loosen the nut on the threaded mount and position the clamp hook in the correct position. Hand tighten the fasteners.
9. Position the cover evenly side to side and rest the cab seal smoothly along the front top edge of the cargo bed.
10. Tighten the nuts until the clamp hooks are secure against the bed rail flange. Tighten each side evenly, tighten only until the tonneau cover cannot shift. **DO NOT** overtighten, overtightening may cause damage to the clamping system.
11. Close the tonneau cover and tailgate.
