Product Safety Recall

N192268490 Increased Brake Pedal Effort

Release Date: September 2019

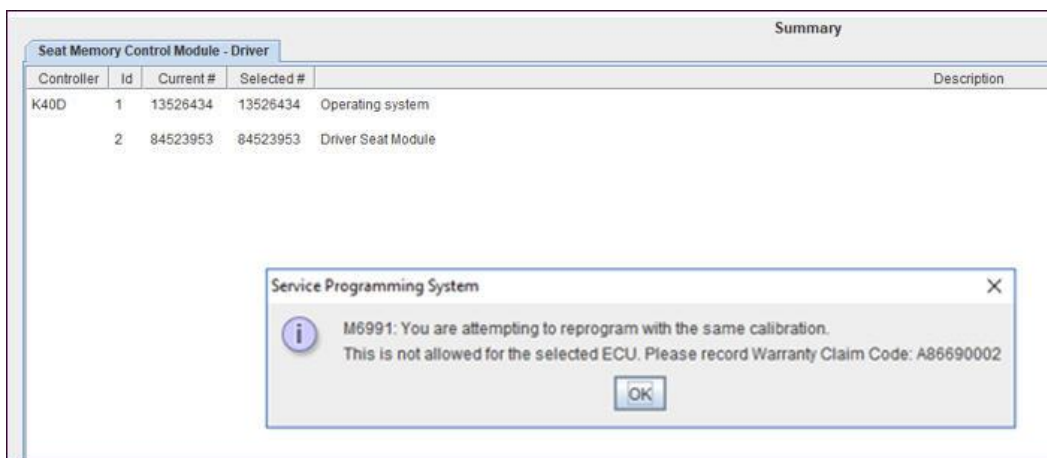
5164840

Note: If the Same Calibration/Software Warning is noted on the SPS Summary screen, record the warranty claim code (WCC) and select OK and follow screen instructions. After a successful programming event, the WCC is located in the Service Programming System dialogue box of the SPS Summary screen. No further action is required. Refer to the Warranty section of the bulletin.
