Product Safety Recall

N192263741 Relay Fuse Box Bolt – US Only

Release Date: September 2019

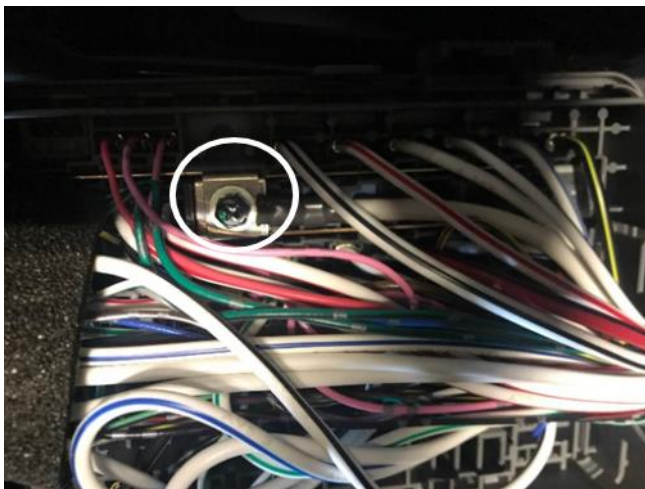
5374438

8. Inspect the relay box power wire for any damage:
 - If there is any damage, take a picture similar to the photo above and contact GM Technical Assistance Center (TAC) for further instructions.
 - If there is NO DAMAGE, continue to step 9.

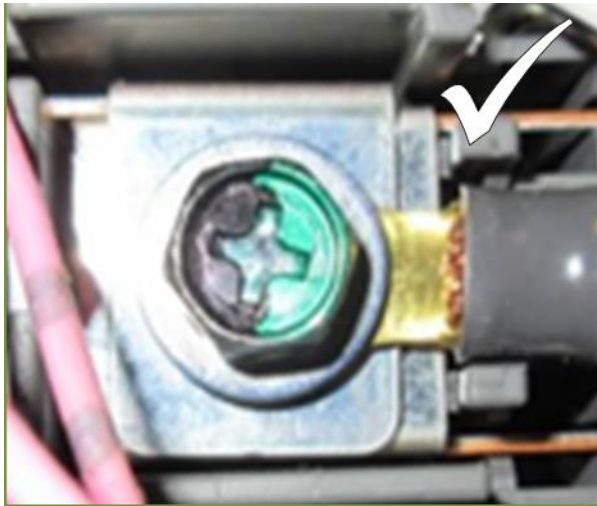
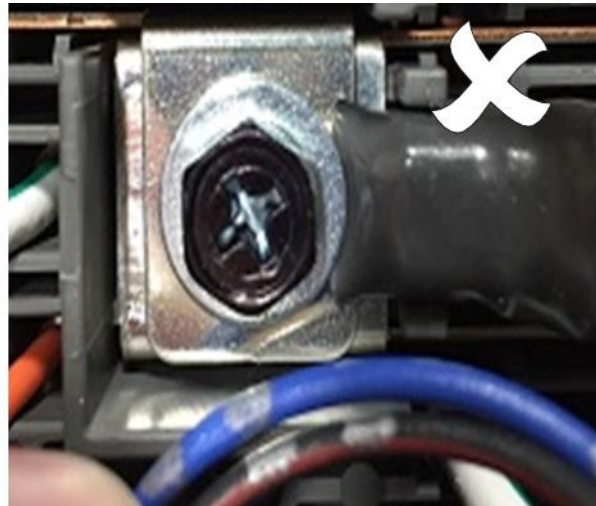
5374440

9. Inspect the wire terminal insulation for excess insulation. See picture above.
 - If the insulation is not ok, proceed to step 10.
 - If the insulation is ok, proceed to step 11.

10. Remove the terminal bolt and lift the terminal away from the fuse box. Using a razor blade, carefully trim away any excess insulation as necessary. Then reinstall the bolt.

11. Torque the power supply terminal bolt to 3.4 Nm (30.1 lb in.)
12. Install the white inner fuse box cover.
13. Install the rubber grommet and tape as necessary.
