# Product Safety Recall

## N192261050 Unexpected Pull To One Side

**Release Date:** December 2019

**Revision:** 02

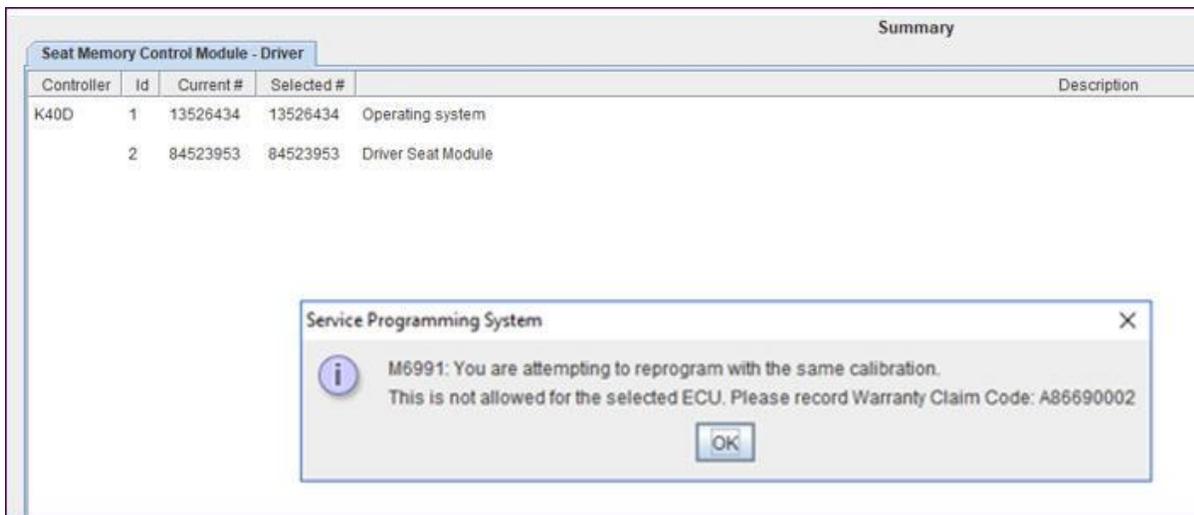
5164840

**Note:** If the Same Calibration/Software Warning is noted on the SPS Summary screen, record the warranty claim code (WCC) and select OK and follow screen instructions. After a successful programming event, the WCC is located in the Service Programming System dialogue box of the SPS Summary screen. No further action is required. Refer to the Warranty section of the bulletin.

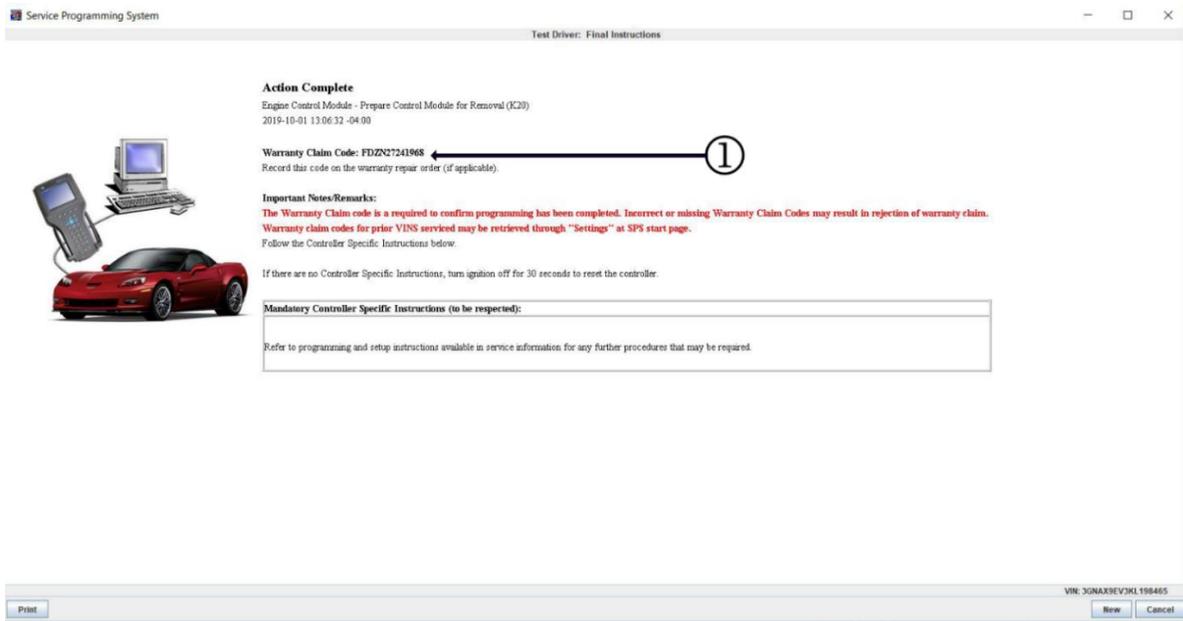
**Note:** To avoid warranty transaction rejections, you **MUST** record the warranty claim code provided on the SPS Warranty Claim Code (WCC) screen on the job card. Refer to callout 1 for the location of the WCC on the SPS screen.

2. Record SPS Warranty Claim Code on job card for warranty transaction submission.
3. CALIFORNIA VEHICLES ONLY: Complete a "Proof of Correction" certificate and provide to the vehicle owner upon recall completion.
