# Product Safety Recall

## N192261050 Unexpected Pull To One Side

Release Date: October 2019

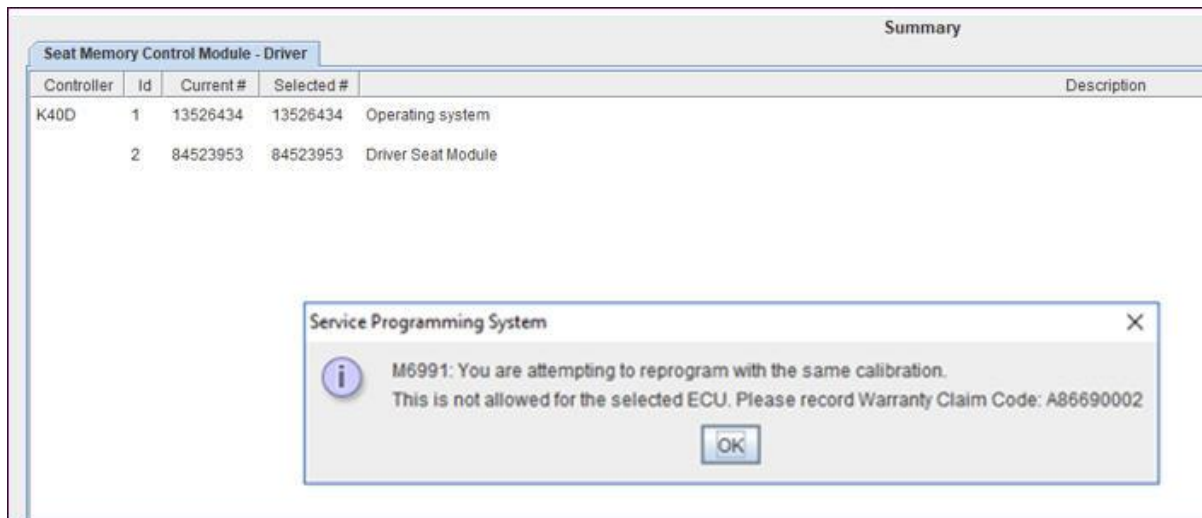
5164840

**Note:** If the Same Calibration/Software Warning is noted on the SPS Summary screen, record the warranty claim code (WCC) and select OK and follow screen instructions. After a successful programming event, the WCC is located in the Service Programming System dialogue box of the SPS Summary screen. No further action is required. Refer to the Warranty section of the bulletin.

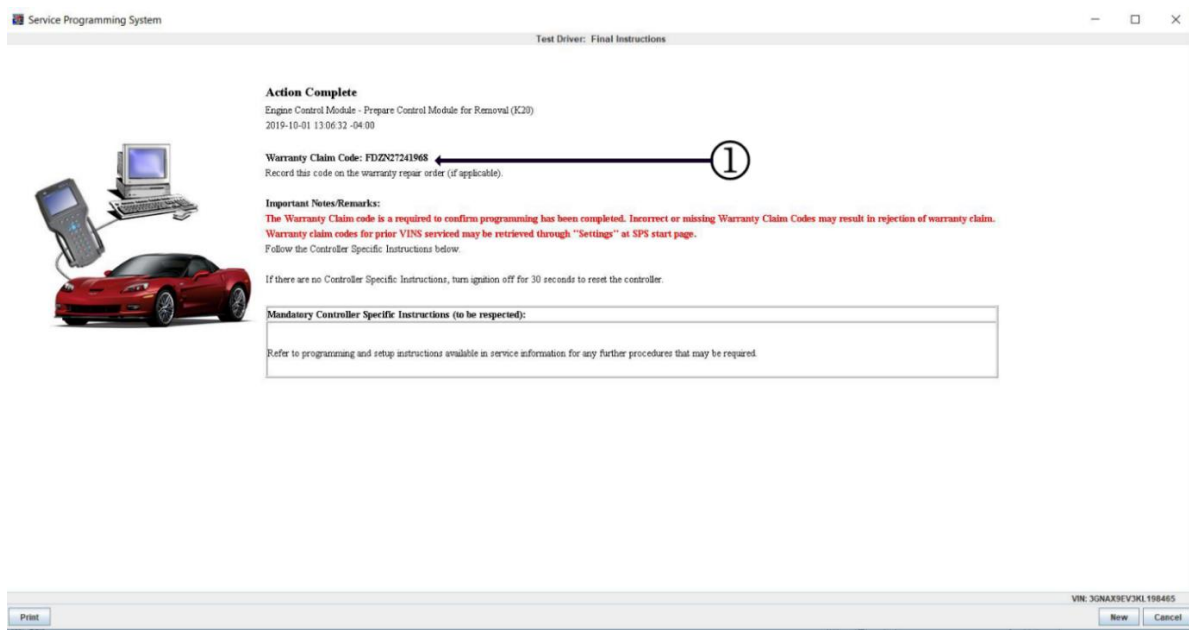
5418111

**Note:** To avoid warranty transaction rejections, you **MUST** record the warranty claim code provided on the SPS Warranty Claim Code (WCC) screen on the job card. Refer to callout 1 for the location of the WCC on the SPS screen.

2. Record SPS Warranty Claim Code on job card for warranty transaction submission.
3. CALIFORNIA VEHICLES ONLY: Complete a "Proof of Correction" certificate and provide to the vehicle owner upon recall completion.
