Product Safety Recall

N192261050 Unexpected Pull To One Side

Release Date: November 2019

Revision: 01

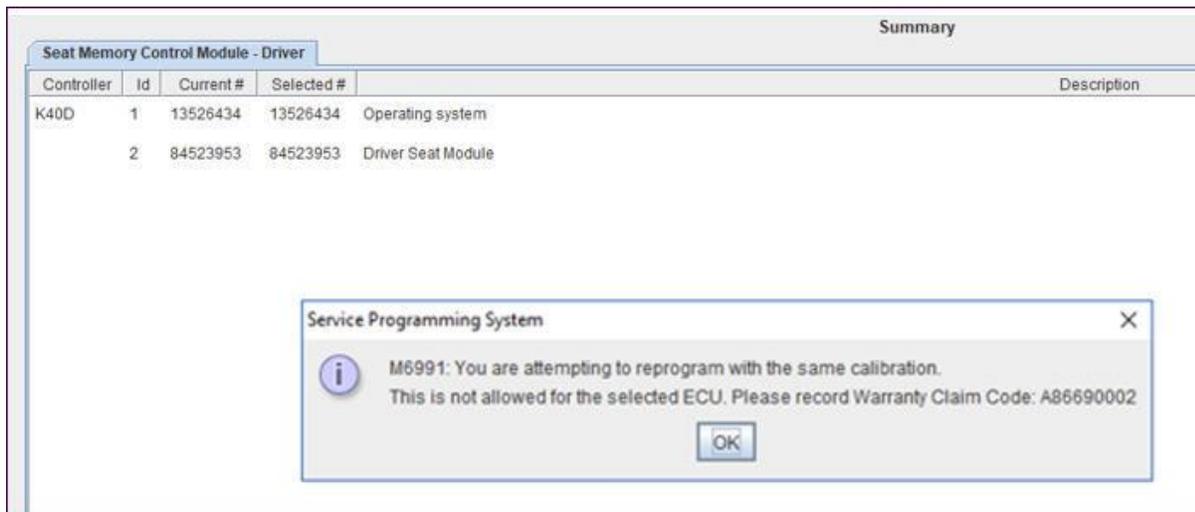
5164840

Note: If the Same Calibration/Software Warning is noted on the SPS Summary screen, record the warranty claim code (WCC) and select OK and follow screen instructions. After a successful programming event, the WCC is located in the Service Programming System dialogue box of the SPS Summary screen. No further action is required. Refer to the Warranty section of the bulletin.

1. Reprogram the Electronic Brake Control Module. Refer to *K17 Electronic Brake Control Module: Programming and Setup* in SI.
