CR184 – Side Stand Replacement

Multistrada 1260 MY 2018 (All versions, Enduro Model Excluded)

Safety Recall Campaign SRV-RCL-19-004

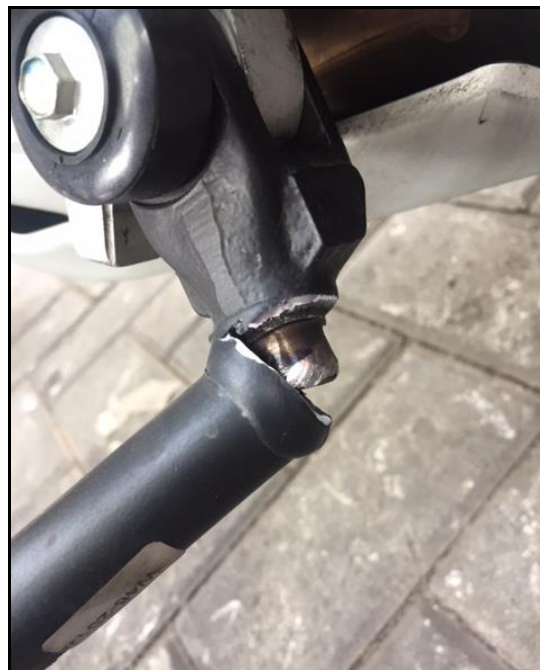
Due to a defect in the manufacturing process of the supplier of the side stand, it is necessary to replace the side stand on a small production run of these specific motorcycles. The side stand could potentially fail at the weld that joins the tube of the stand itself with the forged upper joint, causing a possible fall of the motorcycle, and may result in damage or injury.
