# Product Safety Recall

## N192273510 Loose Alternator Cable

**Release Date:** December 2019

| <b>Condition</b> | General Motors has decided that a defect which relates to motor vehicle safety exists in certain 2019 – 2020 model-year Chevrolet Silverado 1500 and GMC Sierra 1500 vehicles. The B+ battery cable rings in these vehicles may have been contaminated with glue residue at the supplier. During normal vehicle operation, the glue may soften and cause the nut that attaches the B+ battery cable to the alternator to loosen over time, which could lead to an intermittent electrical connection or arcing. During the supplier’s assembly process, excess glue may not have been completely removed from the B+ battery cable rings, resulting in glue contamination that could affect the joint connection between the cable ring and the alternator. An intermittent electrical connection between the B+ battery cable and the alternator could cause the vehicle to stall. The intermittent connection could also lead to arcing, which could generate sufficient heat to damage surrounding material and increase the risk of a fire. |

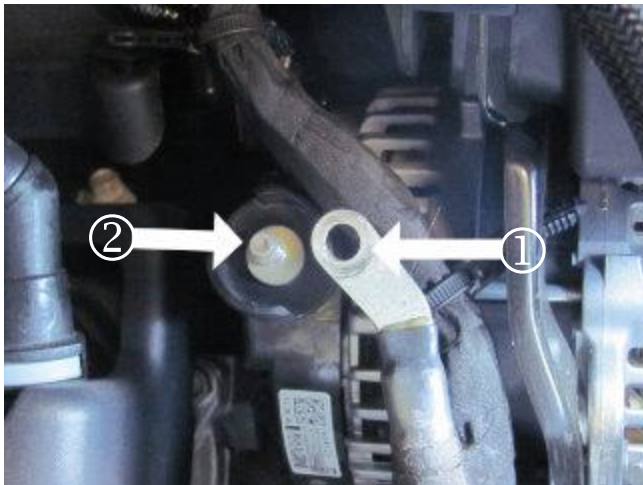
5459038

4. Inspect the cable terminal (1), cable terminal on the generator (2) and attachment nut for any signs of heat damage.
  - If **NO HEAT DAMAGE** is found, proceed to step # 5.
  - If **ANY HEAT DAMAGE IS INDICATED, STOP THE REPAIR**, properly reassemble nut at the generator (Important: use caution when reassembling so that damage to nut does not occur). Service parts are currently NOT available. This vehicle must be held and not delivered to customers, dealer-traded, released to auction, used for demonstration purposes or any other dealer use until further instructions are received.

**Important: A small amount of glue is expected to be present around the shrink sleeve. The inspection procedure is for glue contamination on the cable terminal where it mounts to the terminal on the generator. This contamination prevents the fastener from tightening as designed and may loosen with heat and vibration.**

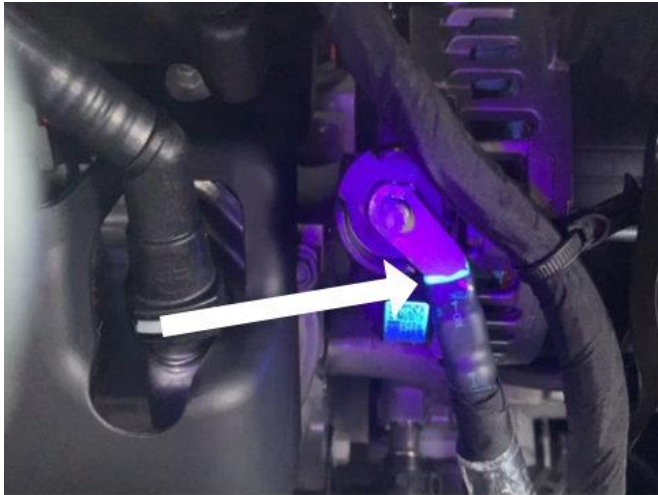
5459040

**Acceptable Glue Coverage Area (Black Light Image)**

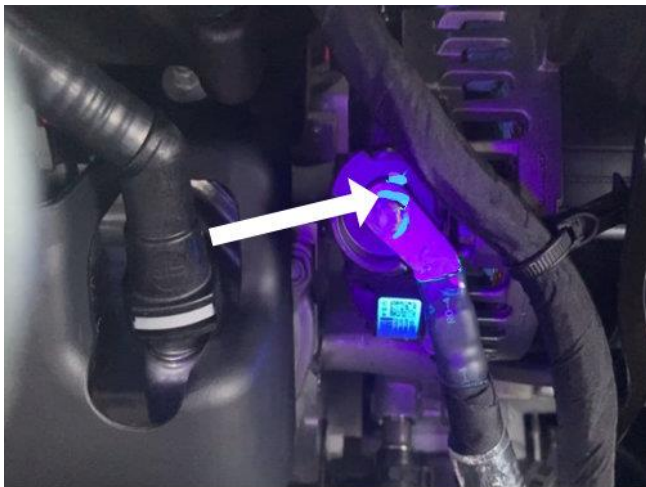
5459042

**Unacceptable Glue Contamination (Black Light Image)**

6. If any glue contamination is found, use a plastic scraper to remove the glue from the cable terminal, attachment nut and the cable terminal on the generator.

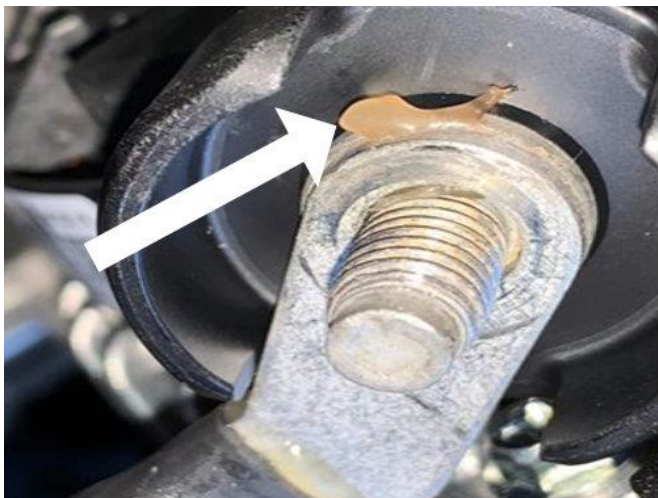
5459046

**Unacceptable Glue Contamination (Daylight Image)**

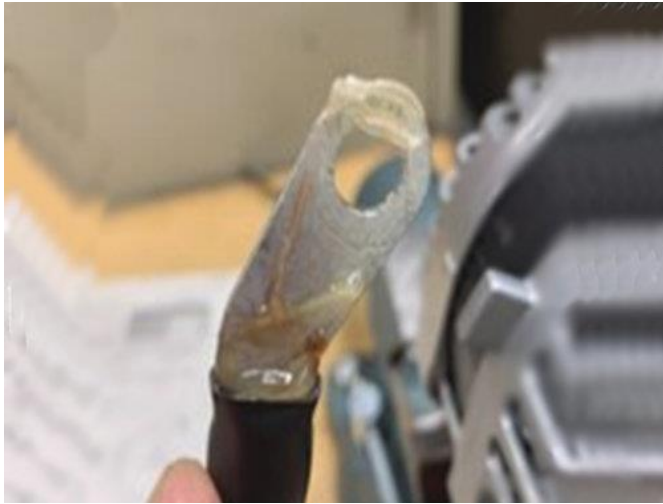
5459052

### Unacceptable Glue Contamination (Daylight Image)

5. Using a high intensity black light kit such as J-28428-E or the equivalent, inspect cable terminal, cable terminal on the generator and attachment nut for any signs of glue contamination. Any glue residue will appear as a blue/purple color under the black light.

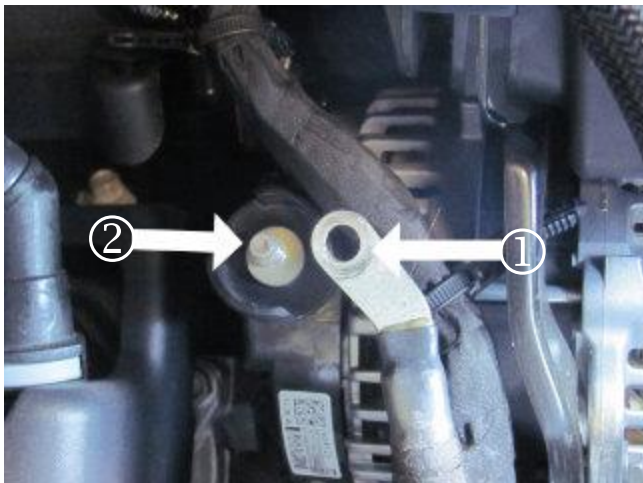
5459038

6. Inspect the cable terminal (1), cable terminal on the generator (2) and attachment nut for any signs of heat damage.
  - If **NO HEAT DAMAGE** is found, proceed to step # 7.
  - If **ANY HEAT DAMAGE IS INDICATED, STOP THE REPAIR**, properly reassemble nut at the generator (Important: use caution when reassembling so that damage to nut does not occur). Service parts are currently NOT available. This vehicle must be held and not delivered to customers, dealer-traded, released to auction, used for demonstration purposes or any other dealer use until further instructions are received.

**Important: A small amount of glue is expected to be present around the shrink sleeve. The inspection procedure is for glue contamination on the cable terminal where it mounts to the terminal on the generator. This contamination prevents the fastener from tightening as designed and may loosen with heat and vibration.**

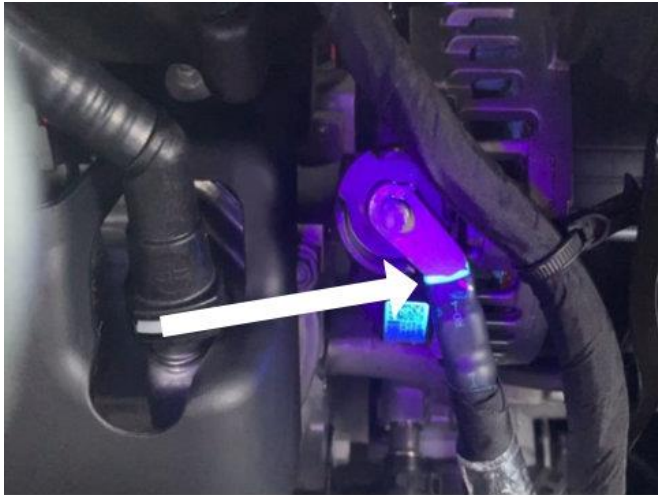
5459040

**Acceptable Glue Coverage Area (Black Light Image)**

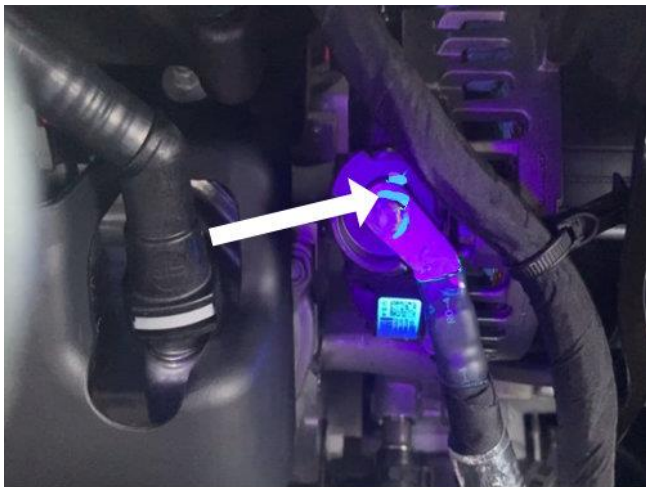
5459042

**Unacceptable Glue Contamination (Black Light Image)**

- If any glue contamination is found, use a plastic scraper to remove the glue from the cable terminal, attachment nut and the cable terminal on the generator.

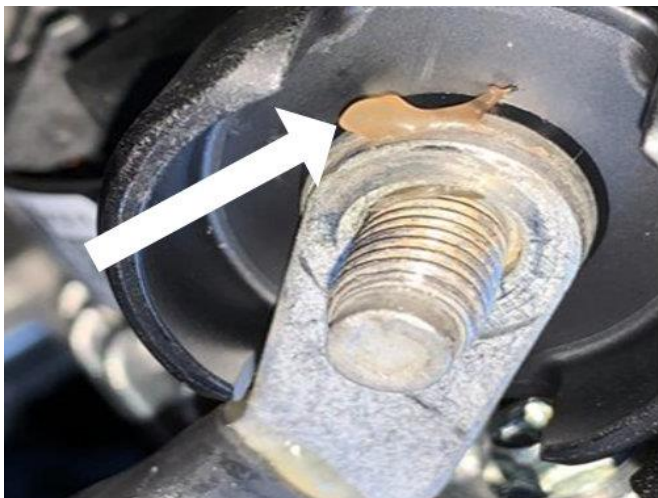
5459046

**Unacceptable Glue Contamination (Daylight Image)**

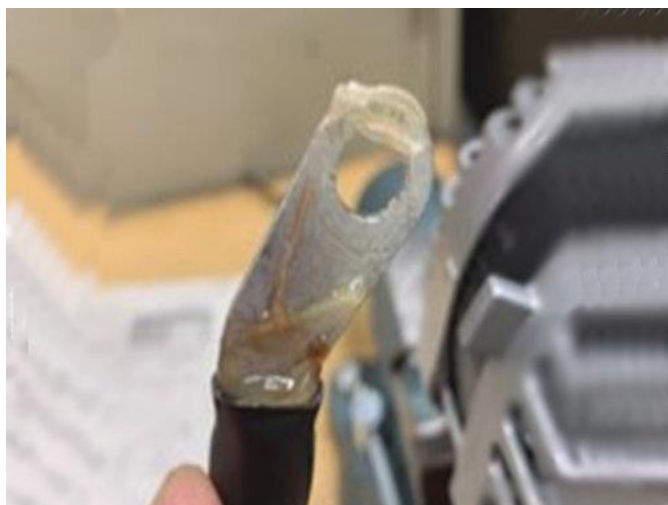
5459052

#### Unacceptable Glue Contamination (Daylight Image)

- Using a high intensity black light kit such as J-28428-E or the equivalent, inspect cable terminal, cable terminal on the generator and attachment nut for any signs of glue contamination. Any glue residue will appear as a blue/purple color under the black light.
