Product Safety Recall

N192273510 Loose Alternator Cable

Release Date: February 2020

Revision: 02

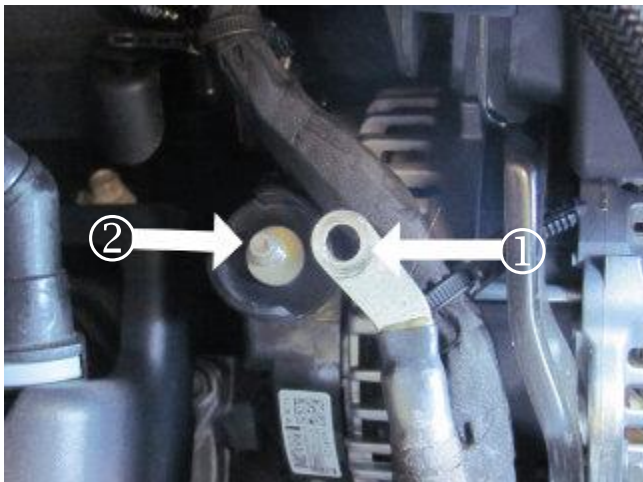
5459038

4. Inspect the cable terminal (1), cable terminal on the generator (2) and attachment nut for any signs of heat damage.

- If **NO HEAT DAMAGE** is found on the cable terminal, generator terminal or attachment nut, they can be inspected for glue contamination, cleaned and remain in the vehicle. Proceed to step # 5 for glue contamination inspection/removal.
- If **ANY HEAT DAMAGE IS INDICATED**, replace the Battery Positive Cable Nut, Generator and/or Starter Solenoid Cable as required. Refer to *Starter Solenoid Cable Replacement* and *Generator Replacement* in SI.

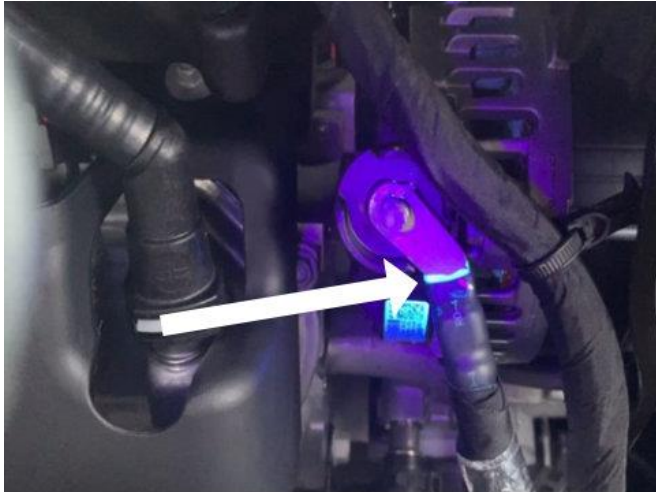
5459040

Important: A small amount of glue is expected to be present around the shrink sleeve. The inspection procedure is for glue contamination on the cable terminal where it mounts to the terminal on the generator. This contamination prevents the fastener from tightening as designed and may loosen with heat and vibration.

Acceptable Glue Coverage Area (Black Light Image)

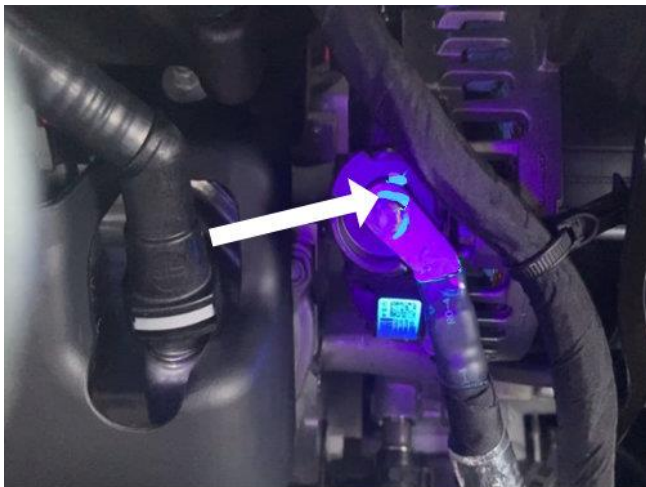
5459042

Unacceptable Glue Contamination (Black Light Image)

5. Using a high intensity black light kit such as J-28428-E or the equivalent, inspect cable terminal, cable terminal on the generator and attachment nut for any signs of glue contamination. Any glue residue will appear as a blue/purple color under the black light.

Important: The cable terminal and terminal on the generator have an anti-corrosion coating. To prevent damage to this coating, **DO NOT** use a metal scraper, abrasive material or chemicals to remove the glue.

6. If any glue contamination is found, use a plastic scraper to remove the glue from the cable terminal, attachment nut and the cable terminal on the generator.

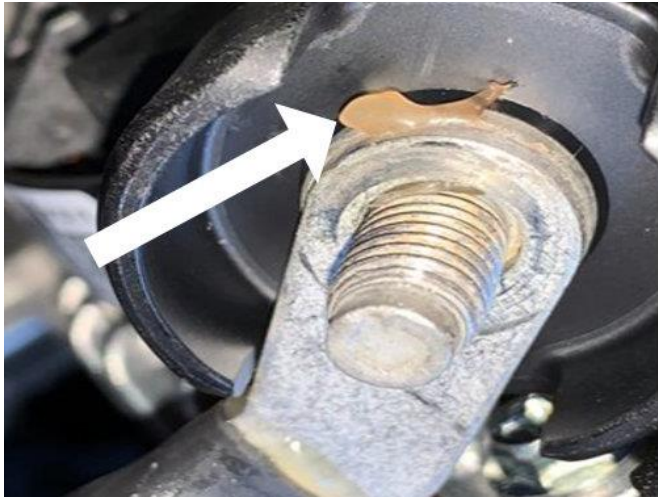
5459046

Unacceptable Glue Contamination (Daylight Image)

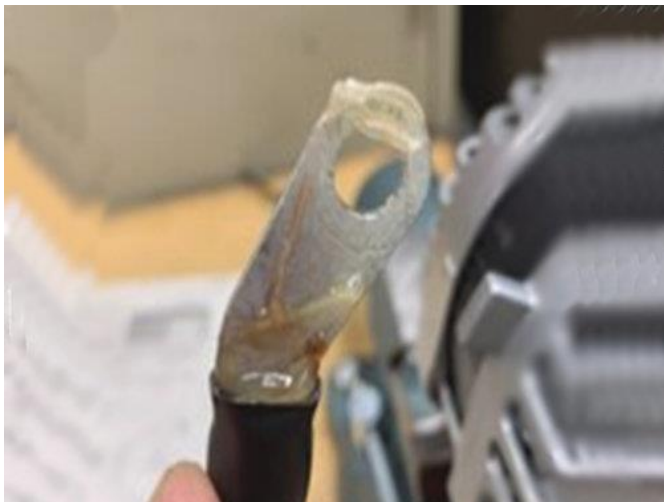
5459052

Unacceptable Glue Contamination (Daylight Image)

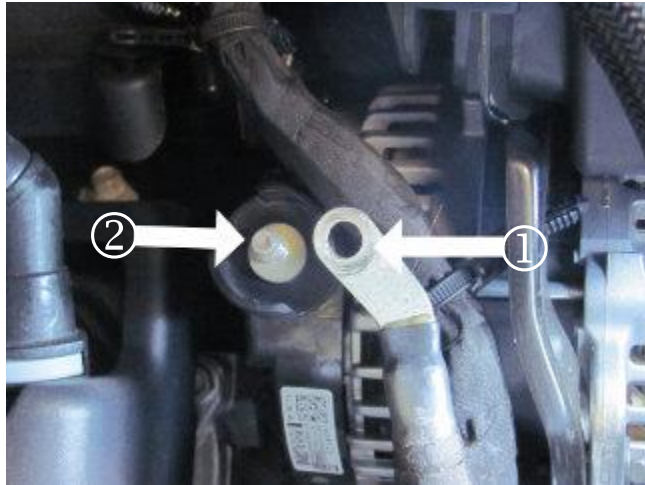
5459038

6. Inspect the cable terminal (1), cable terminal on the generator (2) and attachment nut for any signs of heat damage.
 - If **NO HEAT DAMAGE** is found on the cable terminal, generator terminal or attachment nut, they can be inspected for glue contamination, cleaned and remain in the vehicle. Proceed to step #7 for glue contamination inspection/removal.
 - If **ANY HEAT DAMAGE IS INDICATED**, replace the Battery Positive Cable Nut, Generator and/or Starter Solenoid Cable as required. Refer to *Starter Solenoid Cable Replacement* and *Generator Replacement* in SI.

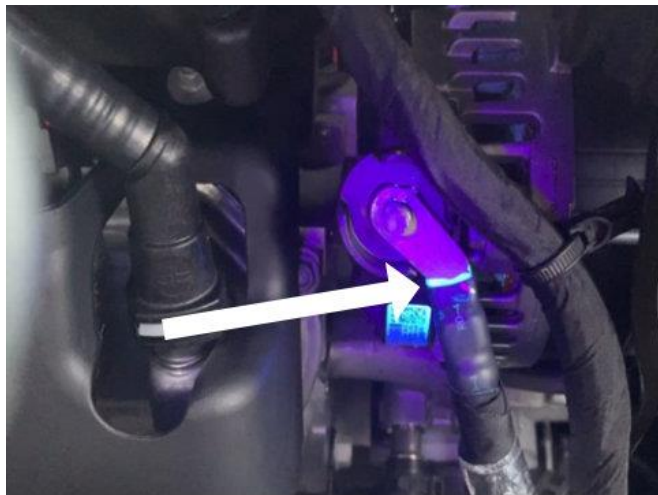
5459040

Important: A small amount of glue is expected to be present around the shrink sleeve. The inspection procedure is for glue contamination on the cable terminal where it mounts to the terminal on the generator. This contamination prevents the fastener from tightening as designed and may loosen with heat and vibration.

Acceptable Glue Coverage Area (Black Light Image)

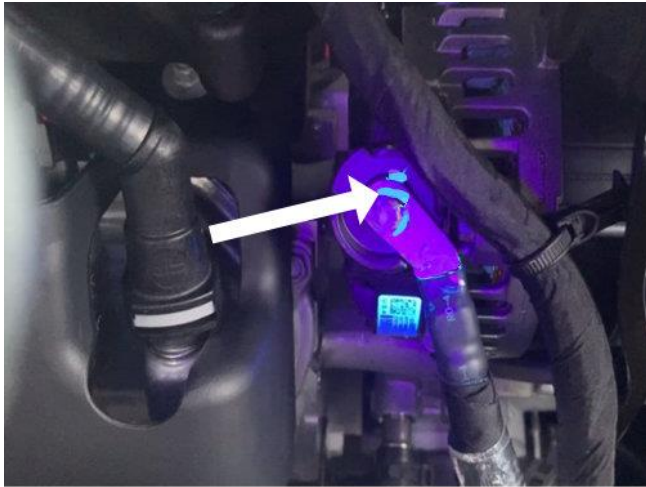
5459042

Unacceptable Glue Contamination (Black Light Image)

7. Using a high intensity black light kit such as J-28428-E or the equivalent, inspect cable terminal, cable terminal on the generator and attachment nut for any signs of glue contamination. Any glue residue will appear as a blue/purple color under the black light.

Important: The cable terminal and terminal on the generator have an anti-corrosion coating. To prevent damage to this coating, **DO NOT** use a metal scraper, abrasive material or chemicals to remove the glue.

8. If any glue contamination is found, use a plastic scraper to remove the glue from the cable terminal, attachment nut and the cable terminal on the generator.

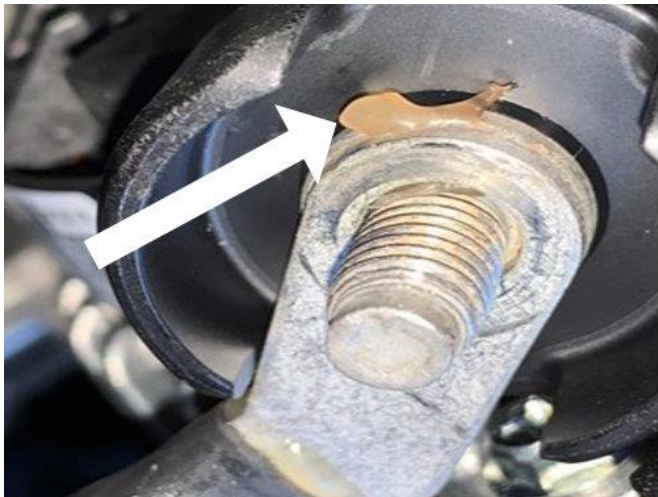
5459046

Unacceptable Glue Contamination (Daylight Image)

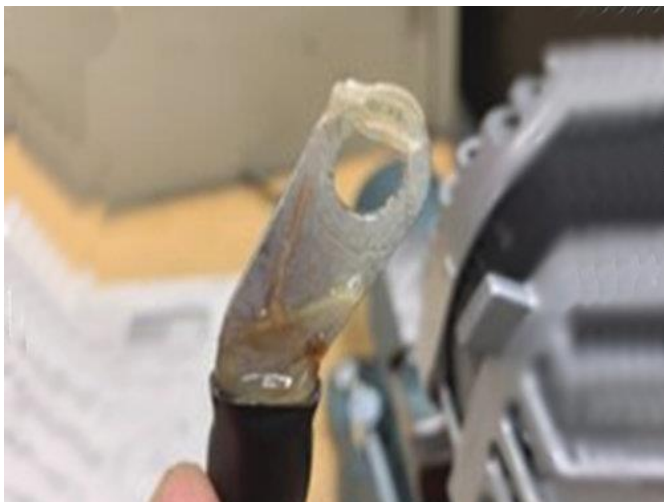
5459052

Unacceptable Glue Contamination (Daylight Image)
