# Product Safety Recall

## N192273510 Loose Alternator Cable

**Release Date:** December 2019

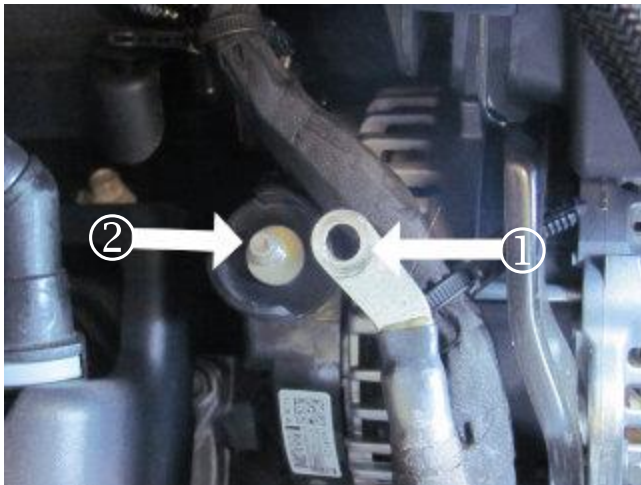
5459038

**Important: A small amount of glue is expected to be present around the shrink sleeve. The inspection procedure is for glue contamination on the cable terminal where it mounts to the terminal on the generator. This contamination prevents the fastener from tightening as designed and may loosen with heat and vibration.**

4. Inspect the cable terminal (1), cable terminal on the generator (2) and attachment nut for any signs of heat damage.
  - If **NO HEAT DAMAGE** is found, proceed to step # 5.
  - If **ANY HEAT DAMAGE IS INDICATED, STOP THE REPAIR**, properly reassemble nut at the generator (Important: use caution when reassembling so that damage to nut does not occur). Service parts are currently NOT available. This vehicle must be held and not delivered to customers, dealer-traded, released to auction, used for demonstration purposes or any other dealer use until further instructions are received.
