## PART 573 Defect and Noncompliance Report

This report serves as ASA Electronics LLC's ("ASA") notification to the U.S. Department of Transportation, National Highway Traffic Safety Administration ("NHTSA") pursuant to 49 CFR § 573 regarding its Voyager brand VOM74MM Mirror Monitor.

Manufacturer's assigned campaign number (where applicable): 19E-009

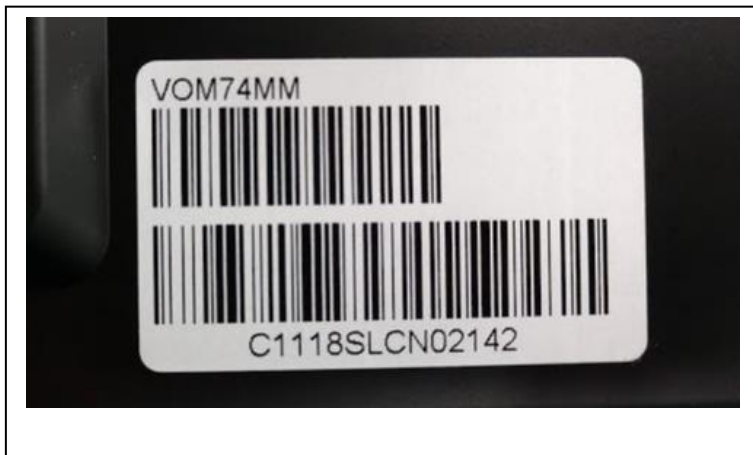
The alphanumeric serial code at the bottom of the label can be used to identify the affected items. As an Example (C1118SLCN02142) the first letter is the revision "C." The following four numbers are a date code in MMY format. The affected products will have serial number starting with A, B, or C.

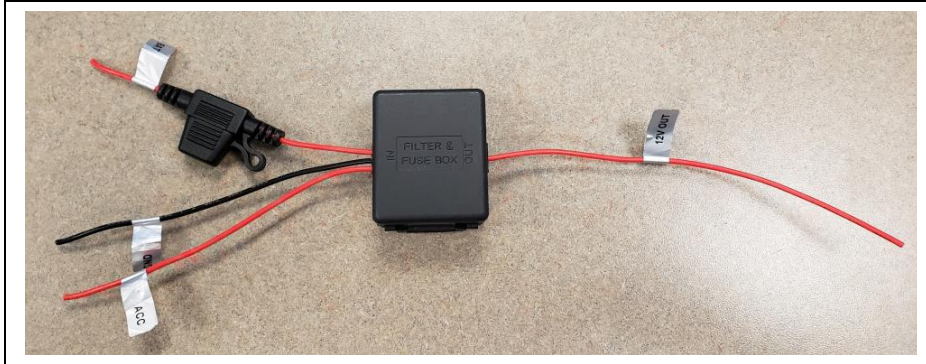
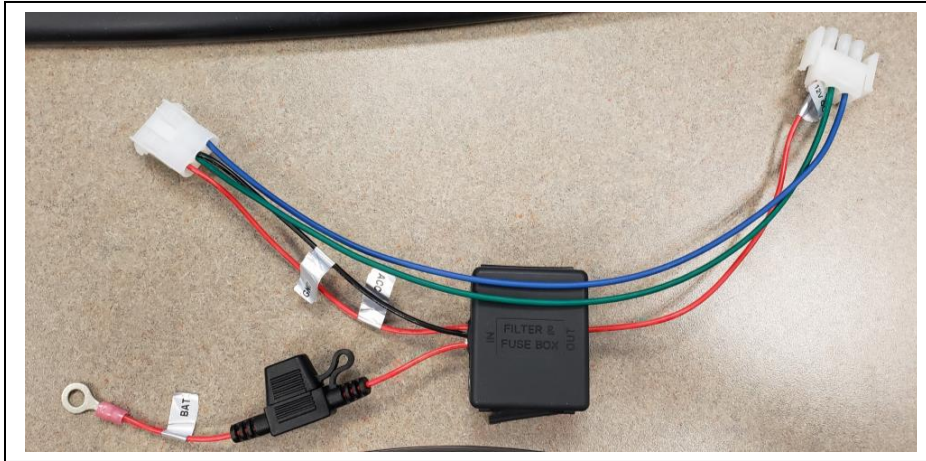
The recall population is different than similar items because after Rev C the default image setting matches the user image setting (starting at Rev D). Certain revision C units are quarantined at ASA Electronics. Any Revision C that are yet to be shipped will have an external capacitor/relay added into the wiring to prevent a voltage drop to the monitor (fix to be used in the field).

The field fix (relay/capacitor) module, which is approximately 1” x 1.5” x 1.5” is added to the wiring of the mirror monitor (mostly under the seat of the truck). See picture in section two above. Also, Rev D serial number will not invert the image if loading default settings.
