**CONDITION OF CONCERN**

**SUBJECT VEHICLES**

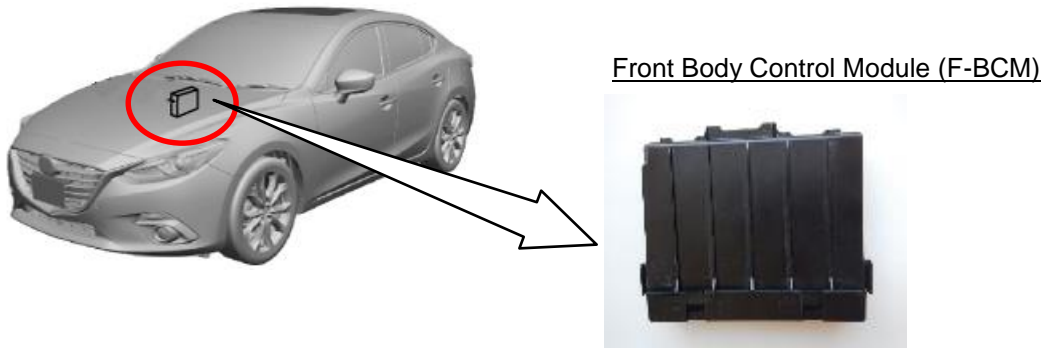
On certain Mazda3 vehicles, the front windshield wipers may become inoperative due to a defective relay located inside the Front Body Control Module (F-BCM) that disrupts electrical power to the wiper motor. The relay becomes defective when metal deposits form due to heat generated during normal operation which causes eventual sticking of the relay contacts.

Drivers may experience reduced or poor visibility while driving due to inoperative front windshield wipers, increasing a risk of crash.

Dealers are instructed to replace the Front Body Control Module (F-BCM) with a modified one. The repair must be performed on all subject vehicles at no charge to the vehicle owners.

Please refer the Repair Procedure document on MGSS for further details.
