**CONDITION OF CONCERN**

**SUBJECT VEHICLES**

Model	VIN range	Build date range
2019 Mazda3 (built at MC)	JM1 BP**** K1 100042 - 136438	From September 25, 2018 through April 19, 2019
2019 Mazda3 (built at MMVO)	3MZ BP**** KM 100048 - 112386	From January 15, 2019 through May 3, 2019

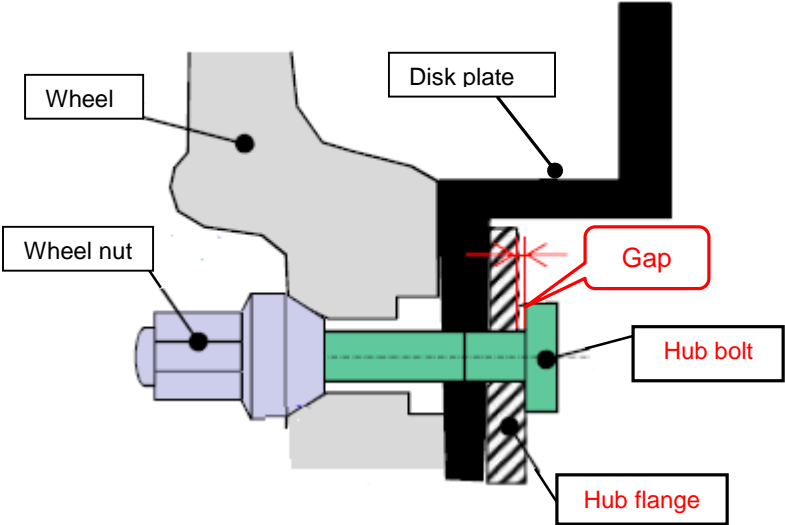
In the worst case, continuous use will lead to a wheel falling off the vehicle. No field cases of wheel separation have been reported, and there have been no accidents, injuries, or deaths related to this concern.

The repair is to retighten the front and rear wheel lug nuts from 137Nm (101 ft. lb.) to 147Nm (108 ft. lb.).
