**CONDITION OF CONCERN**

**OUTLINE OF REPAIR**

**SUBJECT VEHICLES**

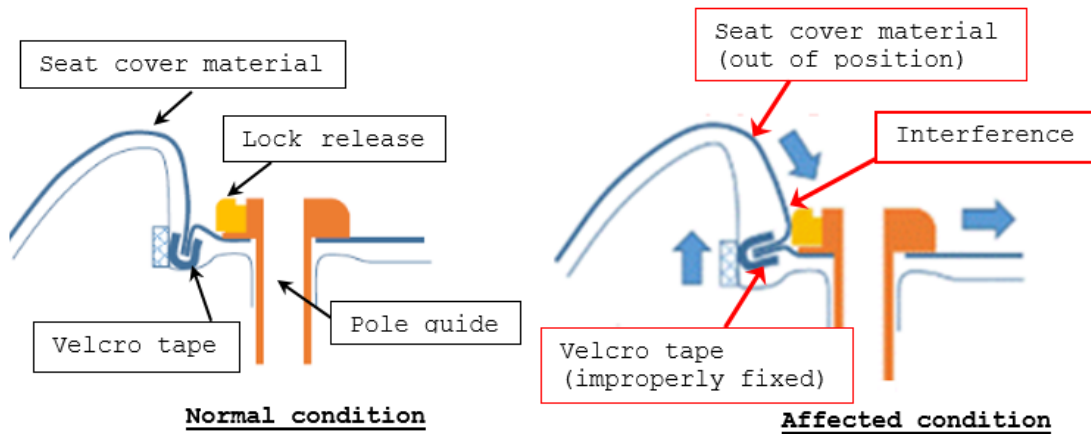
On certain Mazda3 vehicles, the seat cover material of the front driver and passenger seatbacks, may interfere with the head restraint lock release button. This may cause the button to be stuck in the released position and in this condition, the head restraint can be moved freely, without the ability to lock the vertical height adjustment at the desired position.

If a crash were to occur, the head restraint could become loose and injure occupants in the vehicle.
