**CONDITION OF CONCERN**

On certain subject vehicles, due to improper installation of the seat cover material of the front driver and passenger seatbacks, the material may interfere with the head restraint lock release button, causing the button to be stuck in the release position. In this condition, the head restraint can be moved freely, without the ability to lock the vertical height adjustment at a desired position.

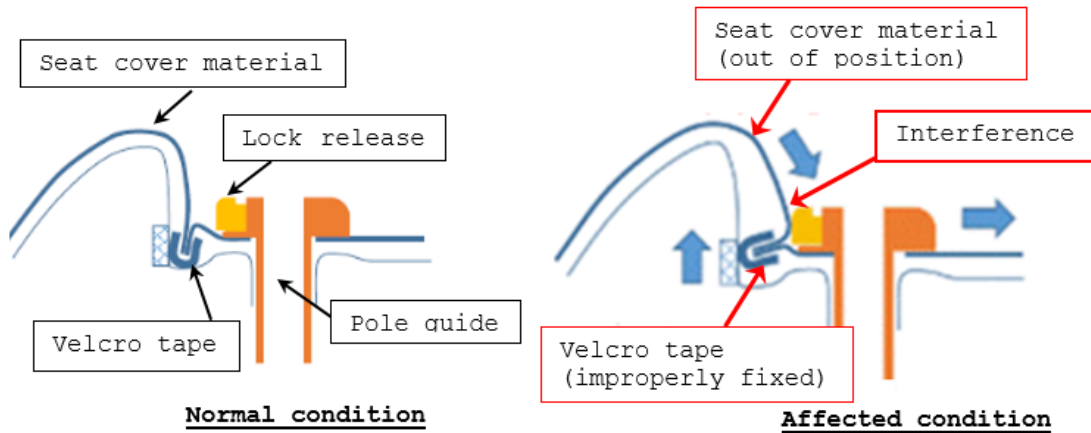
If a crash were to occur, the head restraint could become loose and injure occupants in the vehicle.
