**CONDITION OF CONCERN**

On certain Mazda3 vehicles, the interior rearview mirror glass may suddenly detach from the mirror housing. The mirror glass adhesive was not adequately bonded to the mirror housing during the manufacturing process of the interior rearview mirror unit. As a result, the interior rearview mirror glass on some units may not have full adhesion strength.

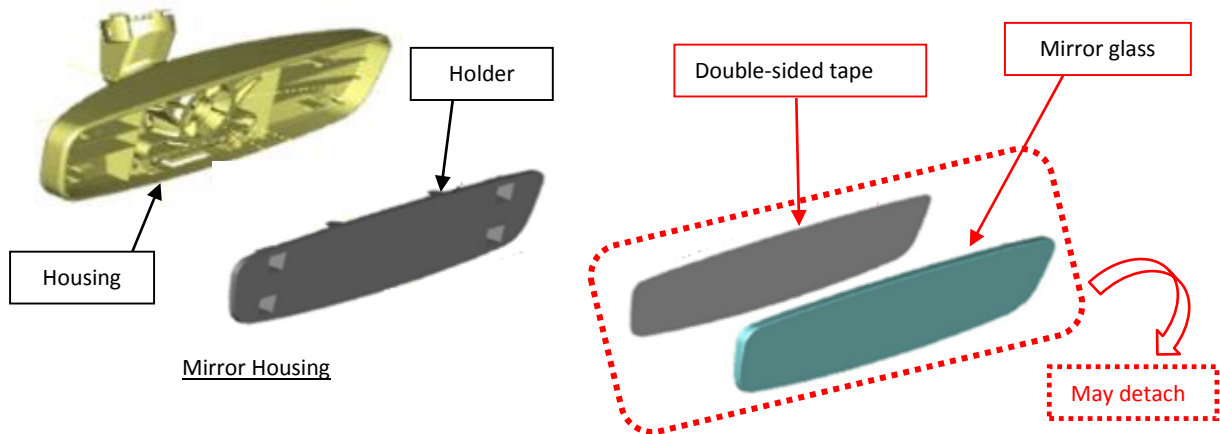
If the interior rearview mirror glass falls off the mirror housing, the driver may have reduced rearward visibility, which may increase the risk of a crash.

Replace the interior rearview mirror unit with an improved part which has proper adhesive force between the mirror glass and mirror housing.
