## CONDITION OF CONCERN

On certain Mazda3 vehicles, the interior rearview mirror glass may suddenly detach from the mirror housing. The mirror glass adhesive was not adequately bonded to the mirror housing during the manufacturing process of the interior rearview mirror unit. As a result, the interior rearview mirror glass on some units may not have full adhesion strength.

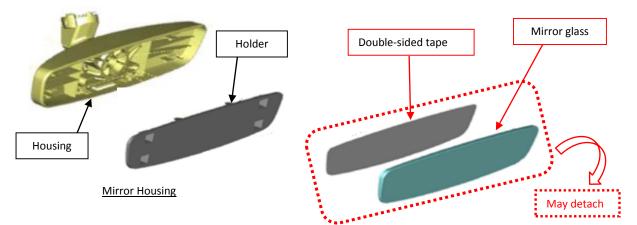
If the interior rearview mirror glass falls off the mirror housing, the driver may have reduced rearward visibility, which may increase the risk of a crash.

Replace the interior rearview mirror unit with an improved part which has proper adhesive force between the mirror glass and mirror housing.
