Technical Service Bulletin
11/19/2019
RECALL

Title: **Safety Recall NHTSA #19V-740 Retainer, Spindle Nut**

TSB - 013

IMPORTANT SAFETY RECALL 19V-740

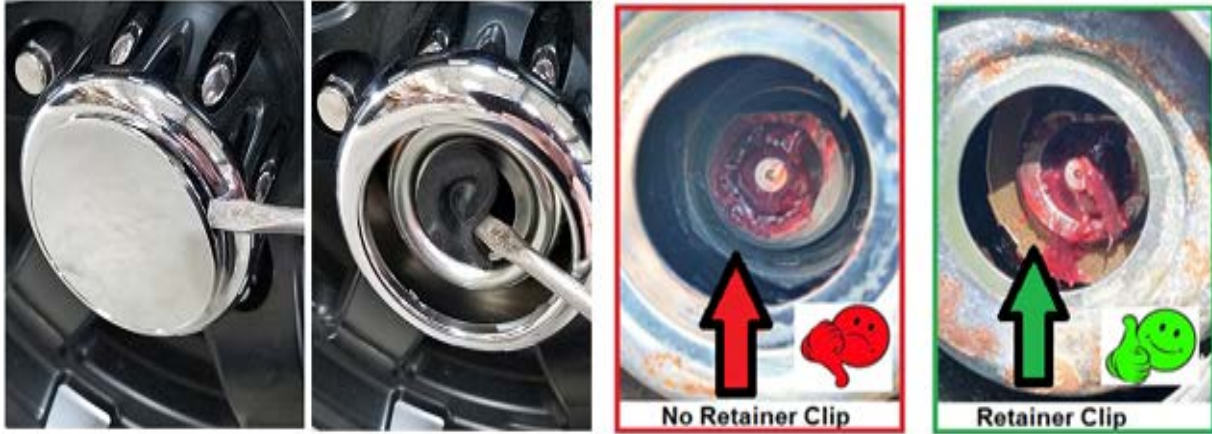
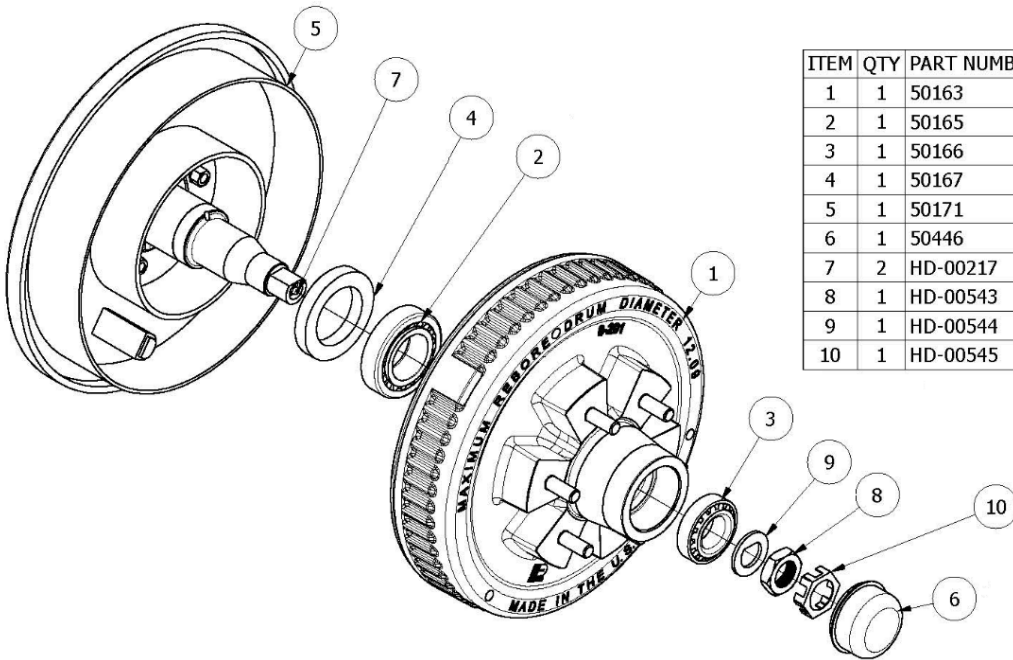
Issue: These units have a condition in which a safety retainer clip may be missing from the Spindle nut. If the clip is missing, over time the spindle nut may loosed and allow The hub and wheel to fall off without warning

Visual inspection for retainer clip *Note: wheel's do not need to be removed*

What will we do? Voyager Industries will supply at no charge, any missing safety retainer clips. These clips are easily installed with instructions provided with the clips. If you are uncomfortable installing these clips, please contact us and we will arrange for this repair at your location. The repair will take less than 30 minutes.

1. Remove the wheels center cap and then the rubber cap from the dust cover
 - Use a flat tip screwdriver or equivalent tool as shown below
2. Visually verify that the retainer clip is installed
3. Reinstall rubber cap and wheel center cap
