Subject: **3 New Takata Recalls (Effective Today, January 16, 2020)**

RECALL CAMPAIGN 20V-016: REPLACE PASSENGER'S FRONT AIR BAG MODULE

RE: Recall 20V-016: Replace Passenger's Front Air Bag Module – B65 02 20

**Passenger Front Air Bag Module
Safety Recall 20V-016
BMW X5 and X6
Model Year 2007-2012
Initial: 1/14/2020**

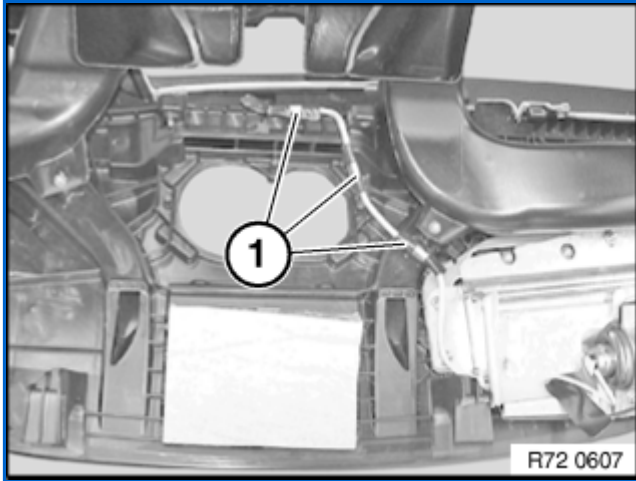
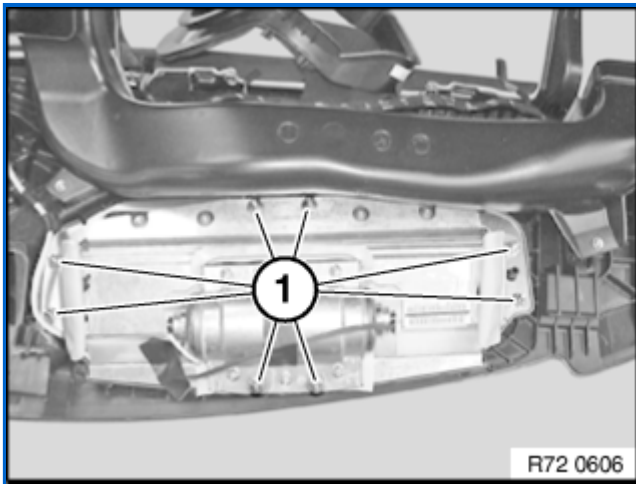
Unclip airbag lead with holders (1) from instrument panel.

Unscrew nuts (1).

Installation:
Replace nuts.
