SAFETY RECALL BULLETIN

SUBJECT: DRIVER SIDE TAKATA NADI INFLATOR – SAFETY RECALL CAMPAIGN		No: SR-20-001	
		DATE: February 2021	
		MODEL: 1998-2000 Montero	
CIRCULATE TO:	<input checked="" type="checkbox"/> GENERAL MANAGER	<input checked="" type="checkbox"/> PARTS MANAGER	<input checked="" type="checkbox"/> TECHNICIAN
<input checked="" type="checkbox"/> SERVICE ADVISOR	<input checked="" type="checkbox"/> SERVICE MANAGER	<input checked="" type="checkbox"/> WARRANTY PROCESSOR	<input checked="" type="checkbox"/> SALES MANAGER

This campaign bulletin instructs dealers to replace the Takata Non-Azide Driver air bag Inflator (NADI) with the countermeasure part.

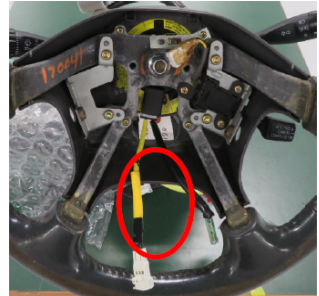
<p>3. Condition after removal of airbag module as left figure</p> <p>This Squib harness (left figure: red circle part) will be modified in next steps</p>

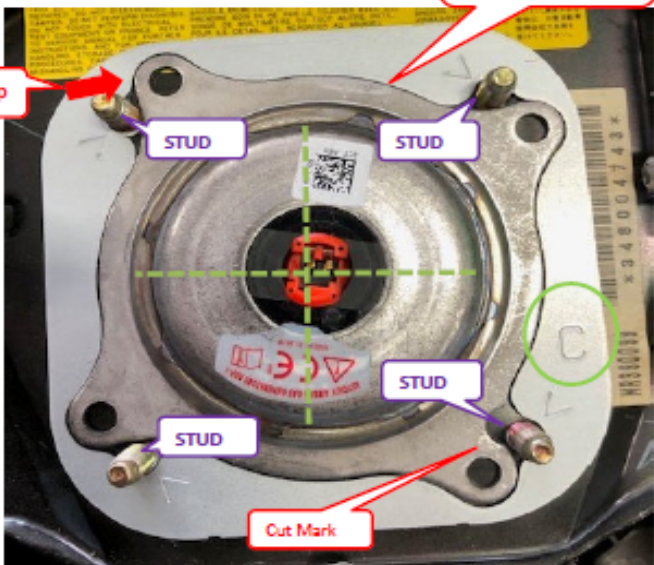
Inflator and Connector
straight up and
overlapping plate C:
Incorrect

NOTE:
4 studs **DO NOT** go
through 4 holes in the
inflator.

<p>Direction of connector</p> <p>Cut mark</p>	<p>2. Installation process</p> <p>(1) Install plate C on the reused air bag module</p> <p>The "C" mark must be at the position of right bottom (as shown in the left figure).</p> <p>(2) Insert new inflator into the inner guide of plate C.</p> <p>See images below for proper installation of the inflator.</p> <p>Check the direction of the inflator connector as shown below.</p> <p>Correct orientation between the "C" plate and inflator</p> <p>No Overlap</p> <p>STUD</p> <p>STUD</p> <p>STUD</p> <p>STUD</p> <p>Cut Mark</p> <p>Inflator and Connector slightly angled and fitted into plate C:</p> <p>Correct</p>

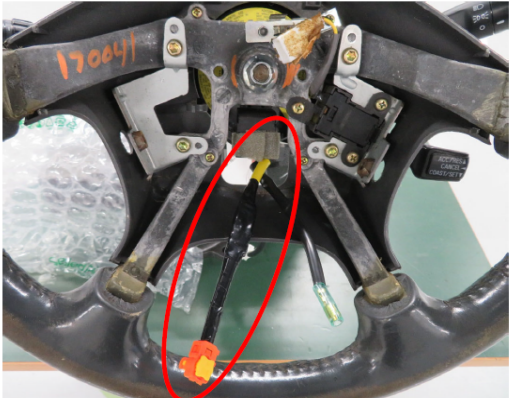
<p>Caution:</p> <ul style="list-style-type: none"> - Wrap insulation tape so that half of tape is overlapped - Wrap insulation tape as much as possible until the end (within 5mm) <p>Condition after modifying the squib harness (red circle point as left figure)</p>

<p>Wrap whole area of modified harness with Insulated tape.</p>	<p>(8) Wrap the entire area of modified harness with insulation tape.</p>
