**\*\* TECHNICAL INFORMATION NOTICE \*\***

**DATE:** February 17, 2021  
**TO:** Mitsubishi Motors US and Puerto Rico Dealer Principals, General Managers, Service Managers, and Parts Managers  
**RE:** Photo Required Condition (PRC) for Driver Side Takata NADI Inflator Replacement Safety Recall  
**TIN NO.** TIN-20-SR-001

**AFFECTED VEHICLES:** Certain 1998 – 2000 Montero vehicles

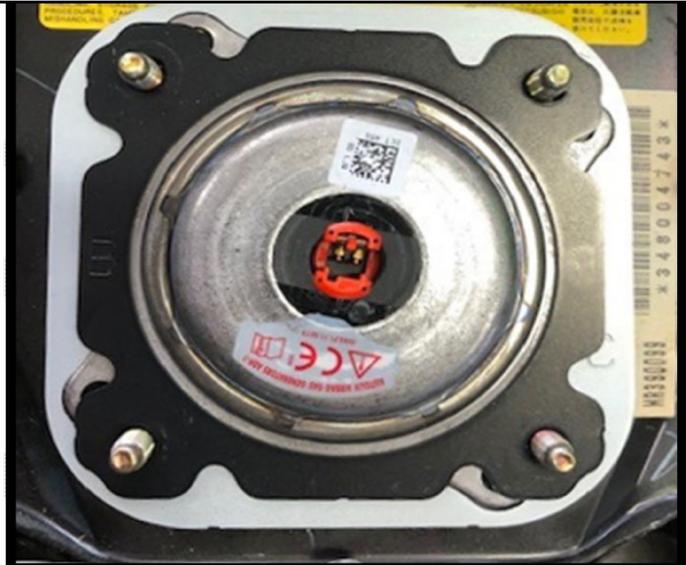
SAMPLE PHOTO OF CORRECT INFLATOR KIT ASSEMBLY

**Therefore, all claims must include a photo of the new countermeasure Inflator kit after assembly—the photo must be posted to the Photos Required Condition (PRC) system in the “RECALL PHOTO/DOCS SUPPORT” category. The photo must clearly show the countermeasure Inflator kit assembled correctly.**
