TO: Mercedes-Benz Dealer Principals, General Managers, Sales Managers, Service Managers, Parts Managers	FROM: Gregory Gunther, Department Manager, Vehicle Compliance and Analysis, Engineering Services
RE: <b>Recall Campaign Launch Notification</b> <b>Transmission Wiring Harness Mounting</b> <b>MY19 290 (GT-Class)</b>	DATE: March 7, 2020

**Transmission Wiring Harness Mounting**

Campaign No. 2020020016, March 2020

SUBJECT: **Model GT-Class vehicles (290 platform)**  
**Model Year 2019**  
**Automatic transmission wiring harness**

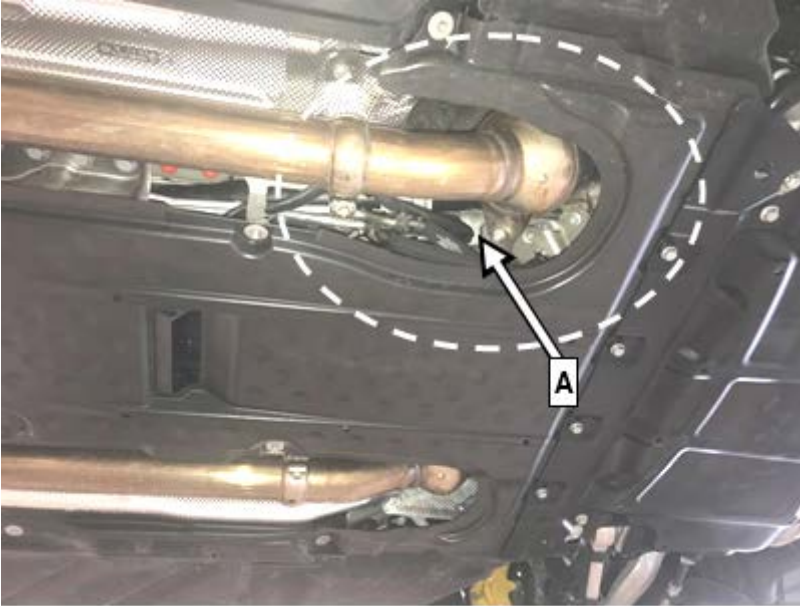
Figure 1

**i** The area of the automatic transmission wiring harness to be checked (**A, Figure 1**) is located on the right-hand side below the drive shaft to the front axle differential.

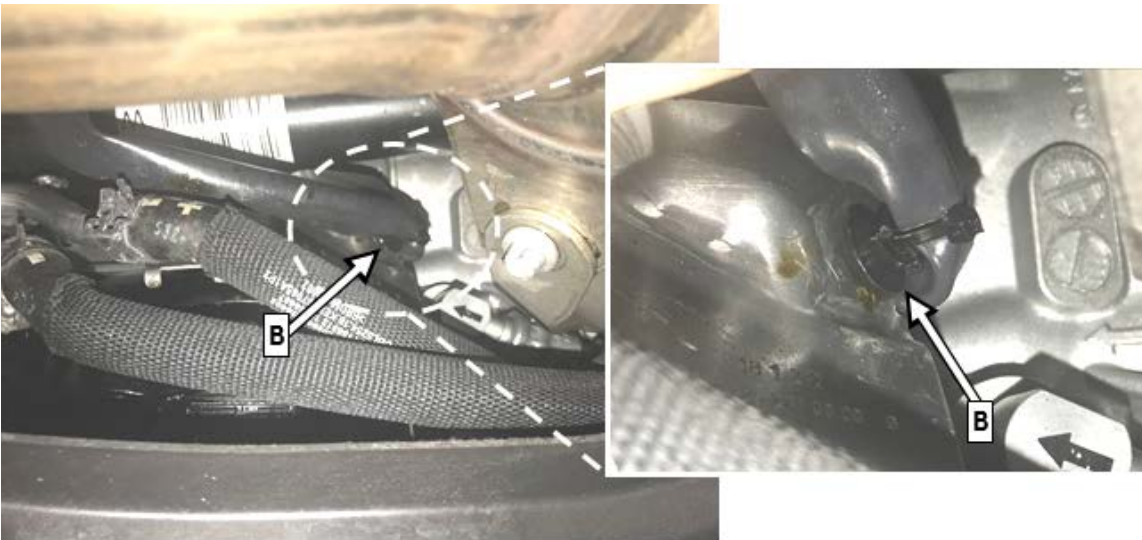
Figure 2 Correct installation

2. Check whether mounting clip (**B, Figure 2**) on automatic transmission wiring harness was installed correctly.

**i** It is possible that the mounting clip is not engaged in the blank holder.

- a. Mounting clip on wiring harness **not** installed correctly: Carry out **work procedure**.
- b. Mounting clip on wiring harness installed correctly: **End measure**.
