| RE: Recall Campaign Notification Model 907 (Sprinter) Model Years 2019 Steering Spindle Bearing | DATE: April 13, 2020 |

Campaign No. 2020030013, April 2020

SUBJECT: **Model 907 (Sprinter), Model Year
2019 Steering Spindle Bearing**

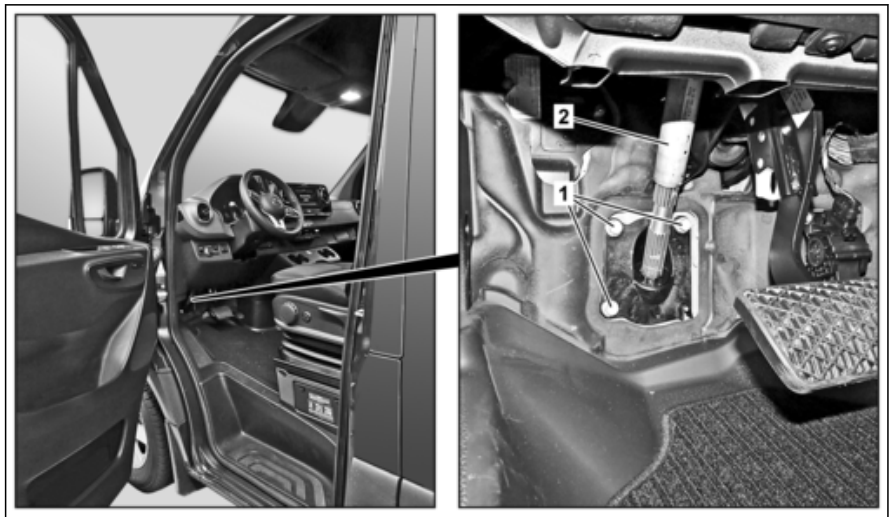
D46.10-A003-05

- 1 Bolts
- 2 Steering shaft

| 2 | Check whether steering shaft (2) is correctly fastened to firewall. | <p>i</p> <p>Check whether all screws (1) are present and fully contact retaining plate of steering shaft bearing. The retaining plate must fully rest against the firewall.</p> <p>Replace loose screws (1).</p> <p>If a screw (1) is missing.</p> <p style="text-align: center;">↓</p> <p>Screw in new screw (1).</p> <p>If a screw (1) is not fully seated:</p> <p style="text-align: center;">↓</p> <p>Replace affected screw (1).</p> <p>If retaining plate of steering shaft bearing does not correctly rest against firewall:</p> <p style="text-align: center;">↓</p> <p>Remove existing screws (1), realign steering shaft bearing, screw in new screws (1).</p> | |

| 3 | Tighten all screws (1) to torque. | Nm Screw/nut, steering shaft bearing to firewall | BA46.10-N-1003-05TS |

| Number | Description | Model 907 |
|---|---|---|
| BA46.10-N-1003-05TS | Screw/nut, steering shaft bearing to firewall | Nm 23 |
