TO: Mercedes-Benz Dealer Principals, General Managers, Sales Managers, Service Managers, Parts Managers	FROM: Gregory Gunther, Department Manager, Vehicle Compliance and Analysis, Engineering Services
RE: Recall Campaign Launch Notification Rework Wiring Harness for Communication Module MY20 190 (AMG GT-Class)	DATE: June 26, 2020

Campaign No. 2020060010, June 2020

SUBJECT: **Model AMG GT-Class (190 platform)**
Model Year 2020
Rework Wiring Harness for Communication Module

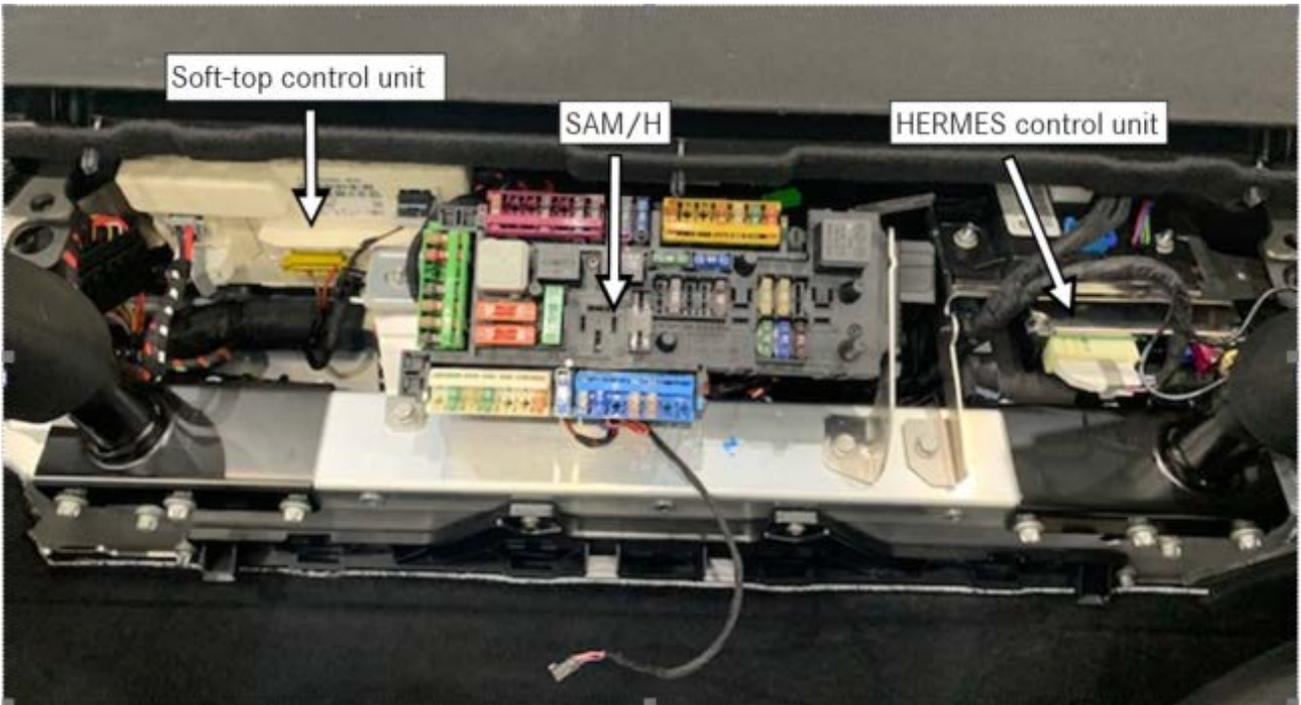
Figure 1

1. Clamp off ground line.
2. Expose HERMES control unit.
 - i For basic data, see **AR82.95-P-0019RGR**.
 - i All operation steps for exposing are described in the WIS document.
 - i HERMES control unit **does not have to** be removed.
 - i The aftermarket ground line is routed from the soft top control unit to the HERMES control unit.

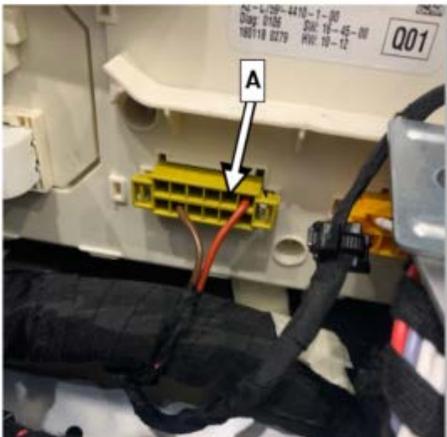
Figure 2

3. Detach plug (A, figure 2) from soft top control unit.

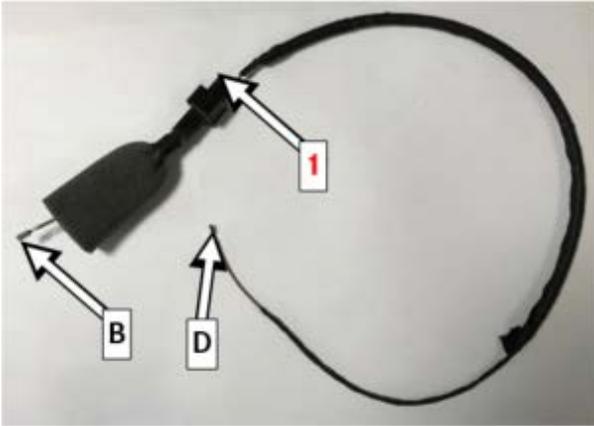
Figure 3

4. Disconnect existing cable (brown) from PIN C connection from chamber 8 (**figure 4**) and connect in free chamber of the socket housing of wiring harness A190 540 26 09 (**1, figure 3**).
5. Insert loose pin (**B, figure 3**) of the aftermarket ground wiring harness into **chamber 8 (C, figure 4)** of the lower row and reconnect plug to soft top control unit.

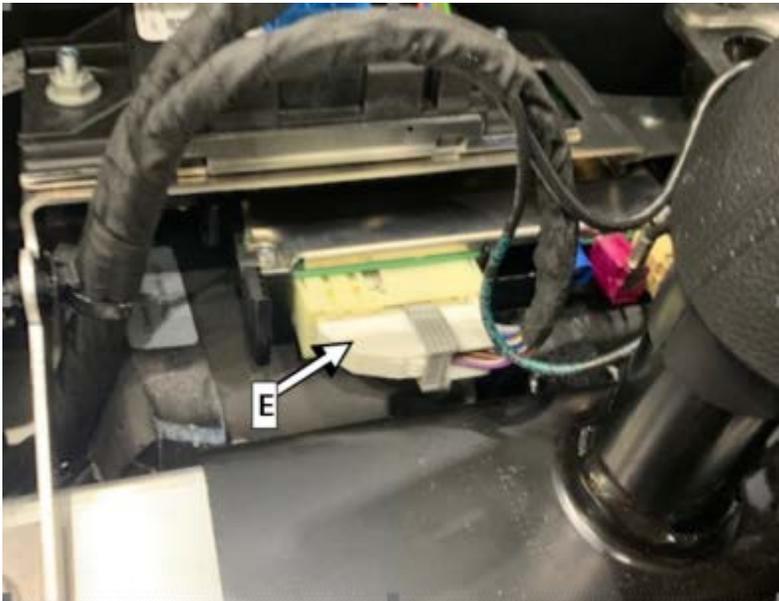
Figure 5

6. Route pin (**D, figure 3**) of the ground wiring harness to the HERMES control unit as outlined in steps 6-7
7. Disconnect plug (**E, figure 5**) from HERMES control unit and remove contact carrier.

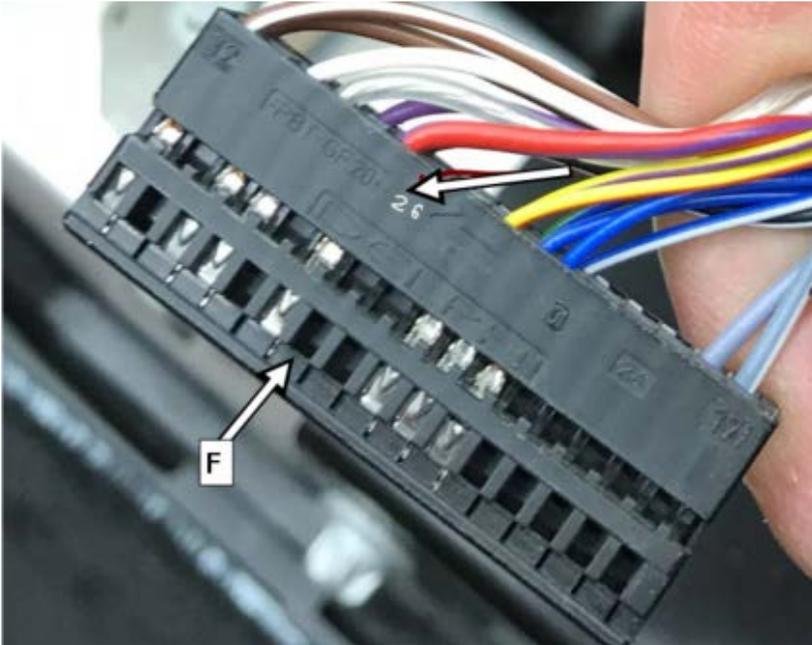
Figure 6

7. Insert loose pin (**D, figure 3**) of the ground wiring harness into **chamber 26 (F, figure 6)**, complete plug and connect to HERMES control unit.
